**North Kitsap United Development**  
**FEASIBILITY REPORT**  
KITSAP COUNTY, WASHINGTON

DEA Job No. RAYORYPP0001

Issued: December 8, 2023

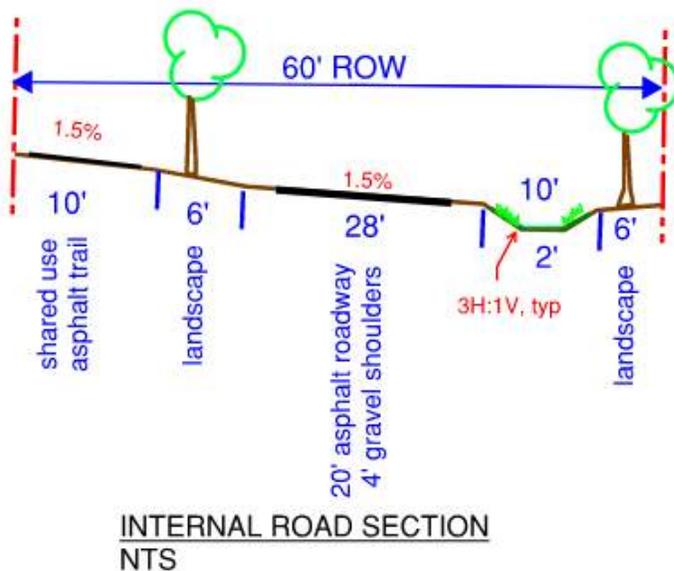
Internal roadways to the proposed development can be either private or public depending on a number of factor such as access to County or State roadways, access to private residences, access to commercial facilities, and access to recreation facilities such as the YMCA, BallFields, and Trails. Internal roads are planned to maintain a rural character or the place complimenting the natural setting and significant open space preserved in the development. The road section identified below is envisioned and is intended to generally follow the 2020 Kitsap County Road Standards for local roads. The local roadways are intended for low volume slow traffic and not intended to ever become a bypass or a higher classification roadway. The largest vehicles are anticipated to be SU-30 (Single Unit Trucks), Garbage Collections, and Fire Apparatus Trucks capable of navigating the roadways without leaving the traveled way.

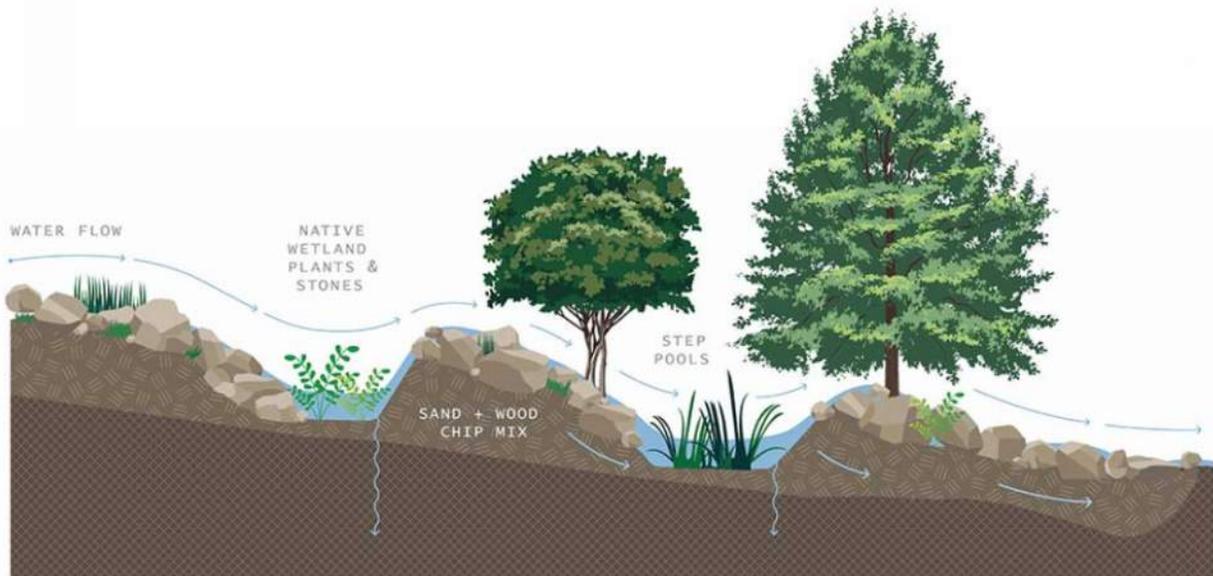
**Exhibit: Swale Energy Dissipation Concept**

Stormwater Site Plans for North Kitsap United will be prepared in accordance with the requirements of the 2021 SWDM. The residential areas are planned to utilize rooftop dispersion with new pollution generating hard surface roadways sheet flowing to open channel swales. The roadside swales are envisioned to utilize natural energy dissipation on steep slopes to control erosion and maintain a natural roadside character, see Exhibit below. Large wetponds are recommended for water quality treatment and flow control for the roadways, parking, commercial areas, and ball fields. While a preliminary site plan has yet to be developed initial feasibility has been performed and features noted in the following sections. The intent of the feasibility study was to determine the features necessary to keep 100% of the developed area drainage on-site, no on-site developed area stormwater discharges to the adjacent off-site areas. Large on-site wetponds can be sized to also accommodate the treatment of portions of the adjacent Stottlemeyer county roadway.

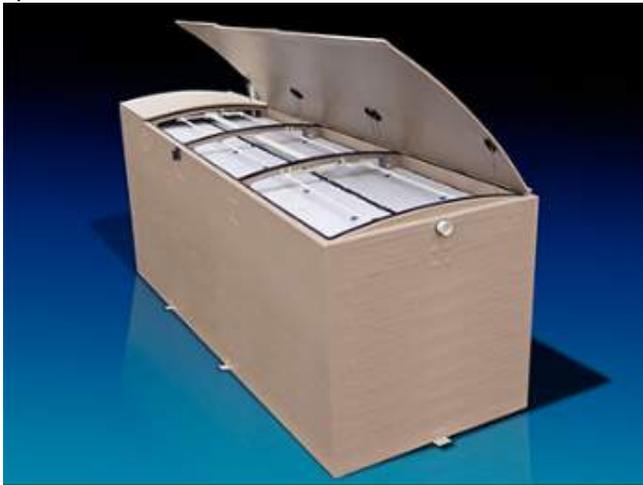
**Figure: AdvanTex AX-Max Module**

AX-Max Treatment Systems are intended for large residential applications or for commercial and municipal applications that require advanced secondary treatment. They provide recirculation and a discharge tank in one module. AX-Max units are ideal for subdivisions, “fringe” development, hotels, resorts, schools, churches, businesses, manufactured home parks, RV parks, campgrounds, rest areas, and truck stops. They are approved for use by DOH and DOE as a LOSS. 95% BOD reductions and 65% Total Nitrogen reductions are possible. A single unit can treat up to 15,000 gpd and can be phased over time as development grows. A 7 unit system was currently built at the Yakima Buena ByPass SubDivision at a cost of \$1.5M excluding the cost of the drainfield and supply piping. A drainfield reduction of up to 50% may be possible with this system.

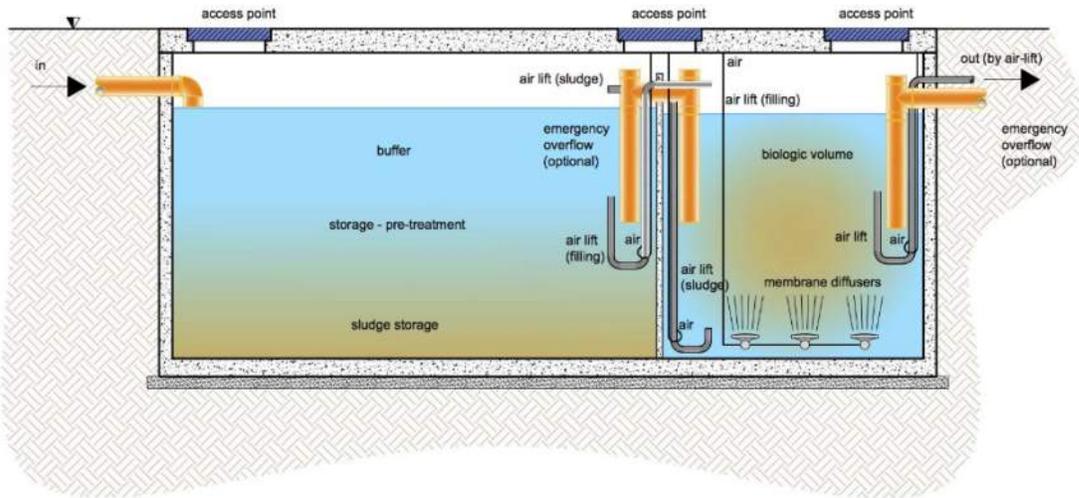
Figure: SBR Diagram

This four-step process can be performed several times per day. Sometimes aeration is cycled on and off during the react stage to encourage nitrification and denitrification for nitrogen removal. While the process does not require costly membranes to operate it can have challenges with settling out the solids over time and must be closely monitored to ensure it is operating properly for BOD and TSS removal. Additional processes are often added for adequate solids handling and removal. Cold temperatures possible at the NKU site would likely mean placing the SBR within a building in a similar manner to the MBR used out at Port Gamble thus increasing it’s cost to be closer to the cost of the MBR. A drainfield reduction of more than 50% may be possible with this system

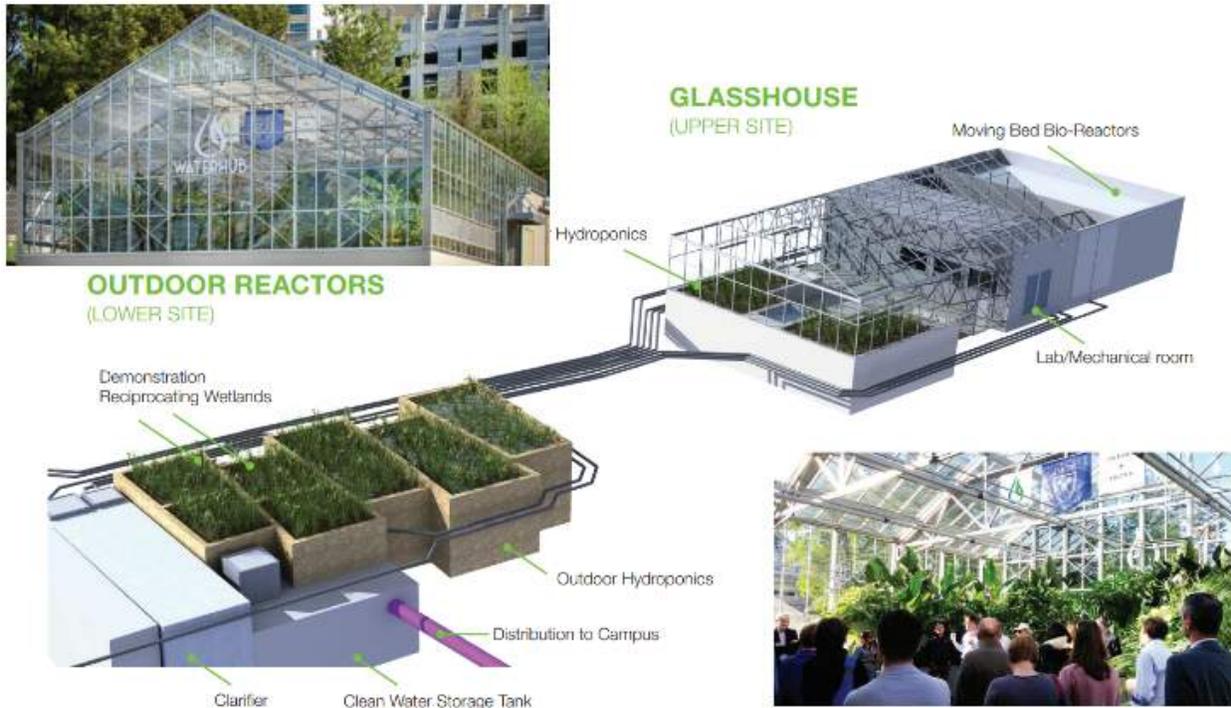
Figure: WaterHub at Emory University

The MBBR process is an advanced biological treatment which utilizes floating plastic carriers (media) within an aeration tank to increase the amount of microorganisms available to treat the wastewater. The microorganisms consume organic material. A company called Sustainable Water created an MBBR process and coupled it with hydroponic plants to create what they called WaterHub for Emory University. In addition to the plastic media they also developed a textile root zone mesh that supports the plant roots while also breaking down the organic matter in 400,000 gallons of blackwater each day. The addition of the plants is very intriguing and makes this a focal point in the landscape.

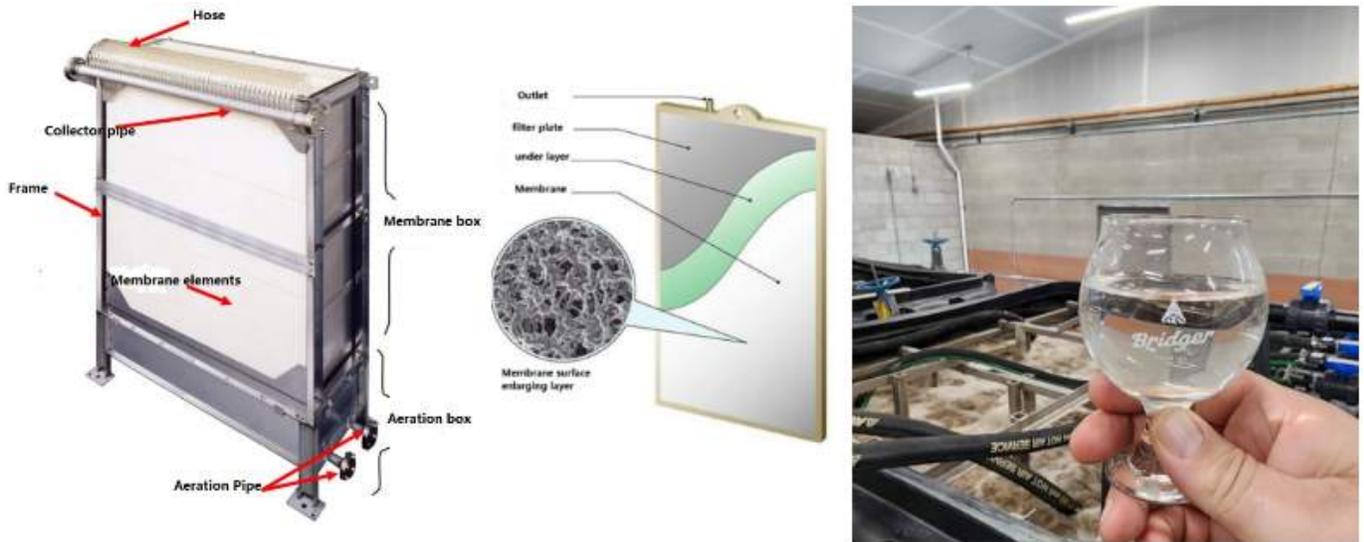
**Figure: Kubota MBR Membrane & A3 USA Treated Effluent**

MBR's are an advanced treatment where sewerage is pre-screened and solids removed followed by forcing the blackwater through a series of membrane plates or hollow tubes which remove BOD, Nitrogen, Phosphorus, and TSS. This process can be repeated multiple times along with nitrifying and denitrifying the water for treatment down to less than 5mg/L of BOD and TSS. There are many different manufacturers of membranes. The Port Gamble project utilized the Ovivo membranes which have recently gone to making entirely ceramic membranes which are quite costly and come with long lead times. Another large scale manufacturer Kabota utilizes their Japanese factory to project a less costly flat plate membrane. GE Zennon membranes are also of the hollow tube or fiber variety. Kabota boasts a smaller footprint than all three of these large scape producers. All three can make reliable treatments and initial discussions with Wilson Engineering suggested that the Ovivo MBR and likely also the Kubota MBR have gone up significantly in the past 3 years and can expect their systems to be significantly more than what they cost at Port Gamble (\$5M to 6M). Dale Richwine, the WWTP program manager out at Port Gamble discussed all three companies at length with DEA and suggested Kubota to likely be the front runner. Another very reliable and significantly less costly and more compact product is the MBR Package Plant by A3-USA. DEA spoke with the A3-USA owner and they just completed a 100,000 GPD system that came in under \$3M.

The MBR used out at Port Gamble was able to achieve a drain field size ~7 times smaller than a conventional system due to the treatment to less than 5mg/l BOD & TSS and by going through a waiver process with the DOH. An MBR with a footprint used by A3-USA and a Drainfield size similar to that from Port Gamble was used for this feasibility study and shown in the Sewer concept that follows.

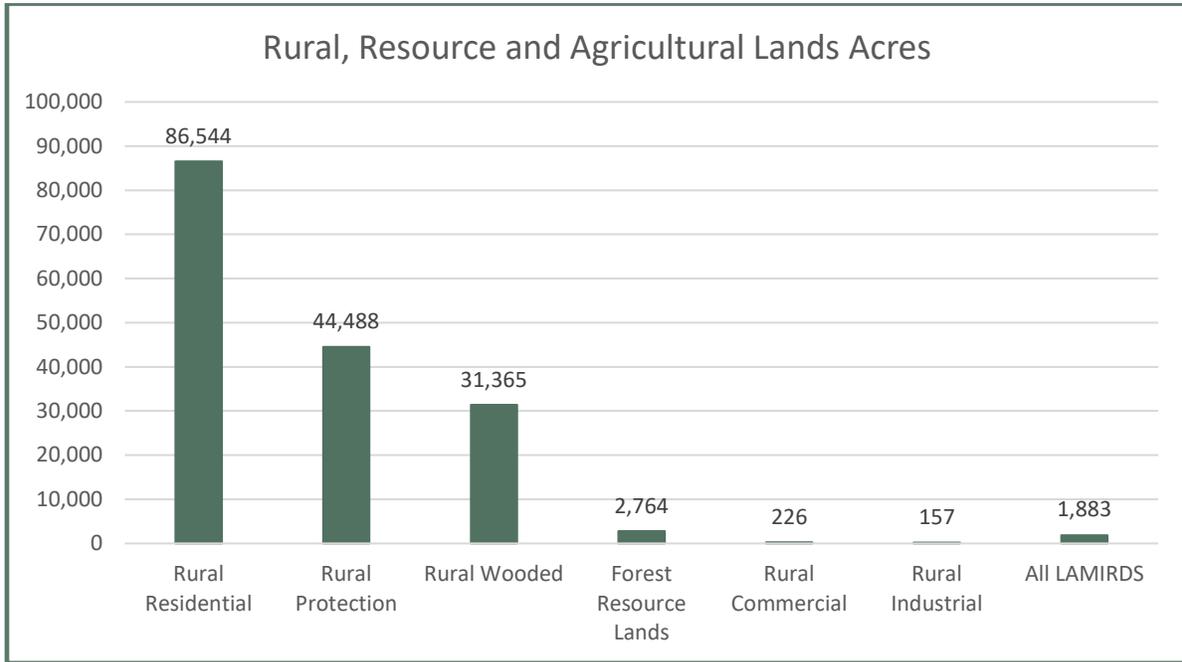
# Exhibit A

## Percentage of Rural Lands by Comprehensive Plan Designation

Percent*	Acres
Rural Residential	34%	86,544
Rural Protection	12%	44,488
Rural Wooded	17%	31,365
Forest Resource Lands	1%	2,764
Rural Commercial	<< 1%	226
Rural Industrial	<< 1%	157
All LAMIRDS**	< 1%	1,883
		167,427
* Kitsap County contains 256,660 acres of uplands		
** Local Areas of More Intense Rural Development		
Source: Kitsap County Zoning Code

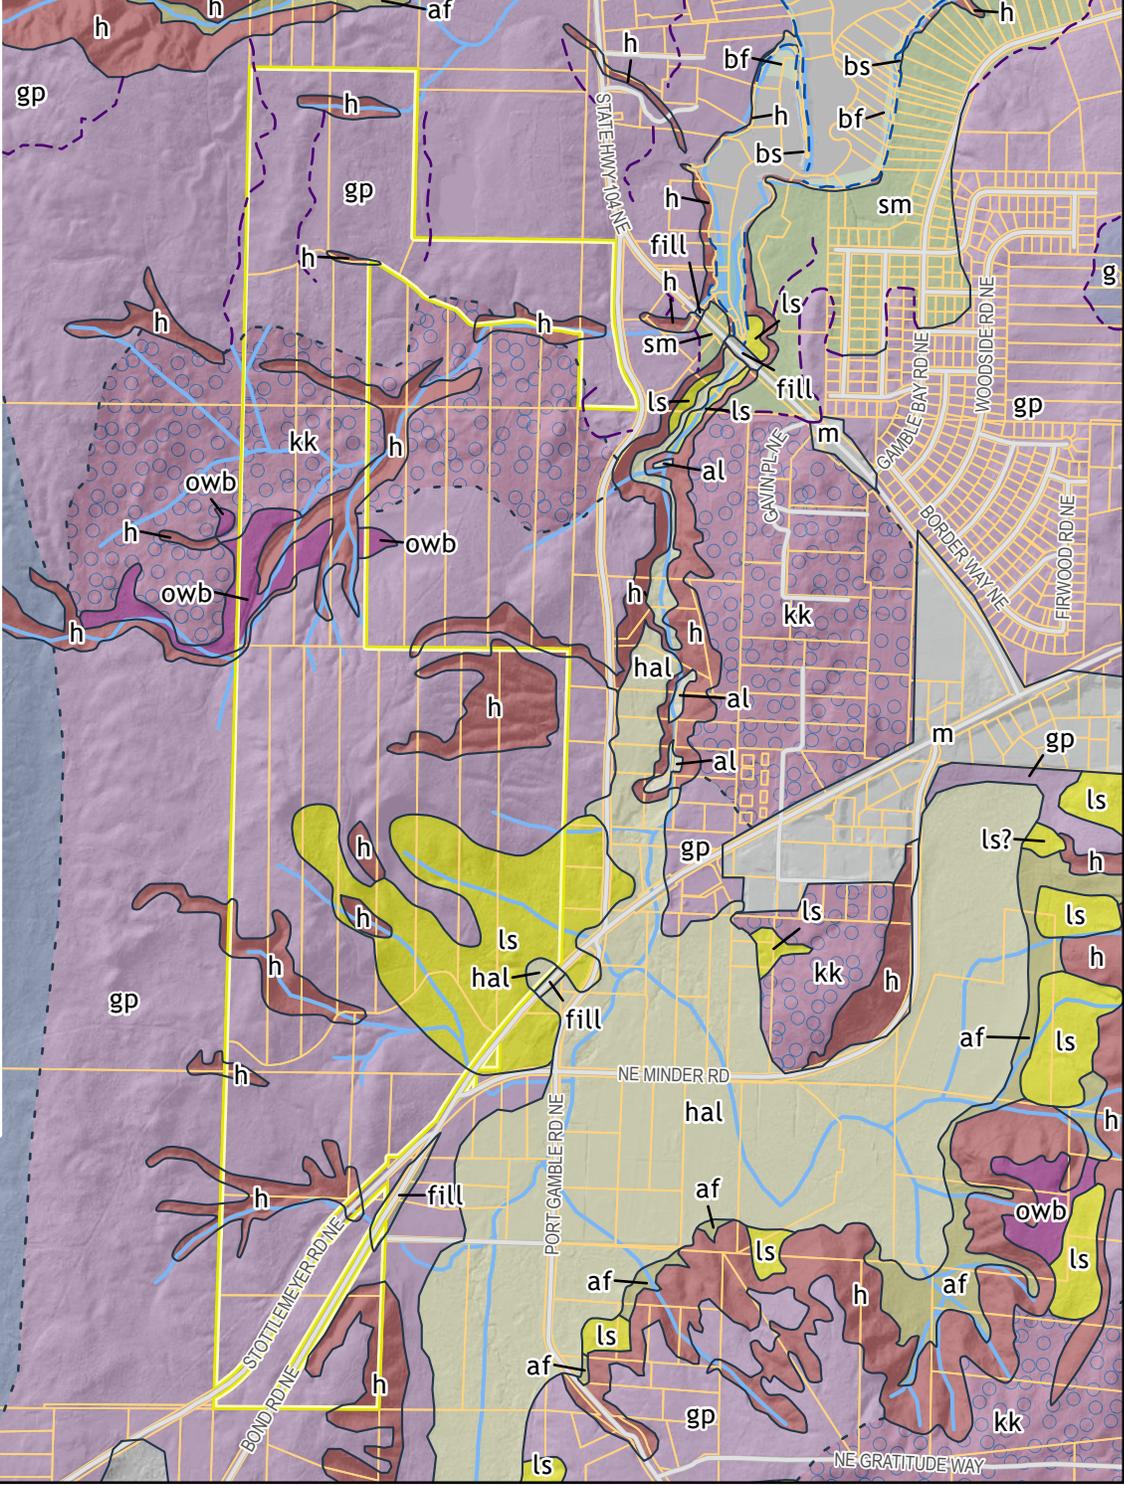
- MAP UNITS**
- CONTACT
  - - - SCRATCH BOUNDARY
  - - - FOSSIL SHORELINE
  - - - SHORELINE
- HOLOCENE SURFACES**
- m - MODIFIED LAND
  - hal - HOLOCENE ALLUVIAL FLAT
  - bs - BACKSHORE
  - bf - BEACH FACE
  - fill - FILL
  - tf - TIDE FLAT
- HOLOCENE AND LATEST PLIESTOCENE**
- af - Alluvial Fan
  - al - ALLUVIAL FLAT
  - h - HILLSLOPE
  - r - RILLED SLOPE
  - ls - LANDSLIDE
- LATEST PLIESTOCENE**
- sm - SUBMARINE SURFACE
  - kk - KAME-KETTLE SURFACE
  - owb - OUTWASH FLAT OF BRETZ AGE
- LATE PLEISTOCENE GLACIAL SURFACE**
- g - GLACIATED SURFACE
  - gf - FLUTED GLACIATED SURFACE
  - gp - POCKMARKED GLACIATED SURFACE

The site location is shown on the “Vicinity Map,” Figure 1. A map of Light Detection and Ranging (LIDAR)-based topography is shown on Figure 2. A regional geomorphology map is shown on Figure 3. The approximate locations of the explorations completed for this study are shown on Figure 4. A schematic hydrogeologic cross-section is shown on Figure 5. Critical area maps are included as Figure 6, Figure 7, and Figure 8. Copies of the exploration logs are included in Appendix A.

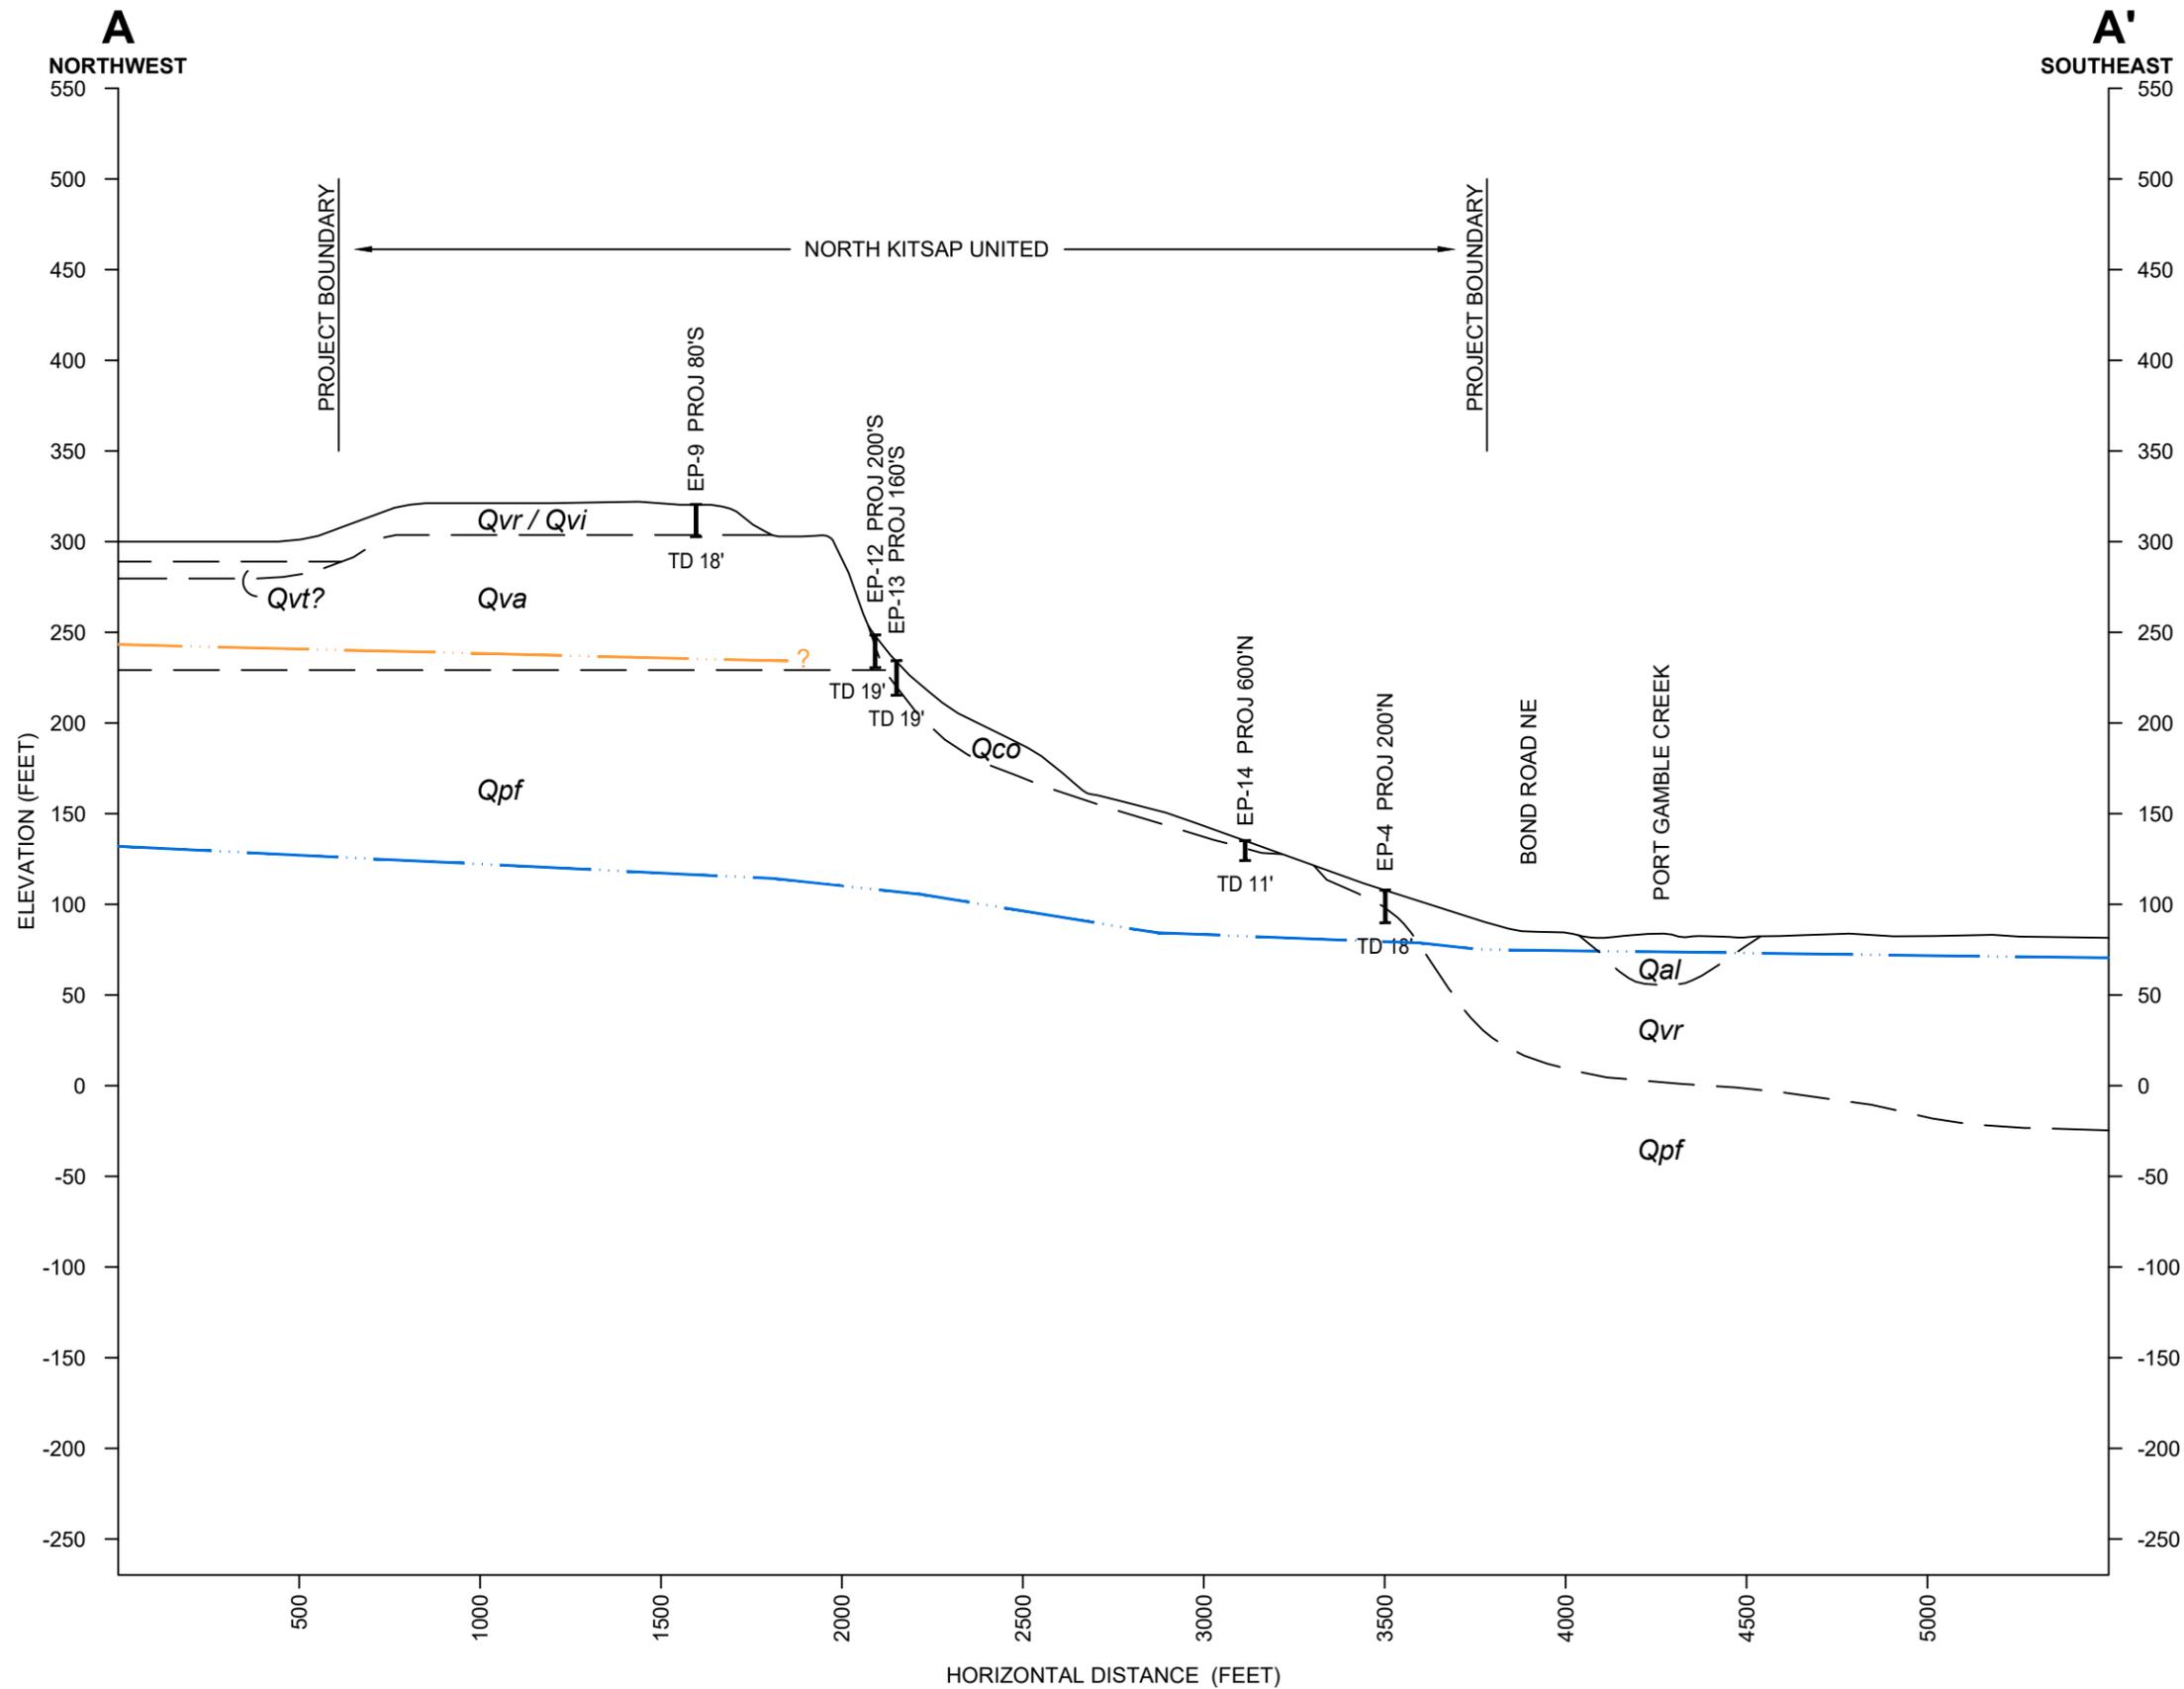
PROJ NO. 20230264H001	DATE: 12/23	FIGURE: 5
--------------------------	----------------	--------------

- Qal ALLUVIUM
- Qco COLLUVIUM
- Qvr VASHON RECESSIONAL OUTWASH
- Qvi VASHON ICE CONTACT
- Qvt VASHON LODGEMENT TILL
- Qva VASHON ADVANCE OUTWASH
- Qpf PRE-FRASER DEPOSITS

targeted exploration pits, and our experience on similar projects. We also reviewed a limited number of water well reports from the Washington State Department of Ecology (Ecology). Detailed review of water well logs outside the study area was beyond the current scope of this project. A schematic hydrogeologic cross-section illustrating conceptual geologic conditions for a portion of the site based upon our observations is presented on Figure 5. The location of Cross-Section A-A' is shown on Figure 4. The following section presents more detailed subsurface information organized from the shallowest (youngest) to the deepest (oldest) sediment types. Copies of the exploration logs are included in Appendix A.

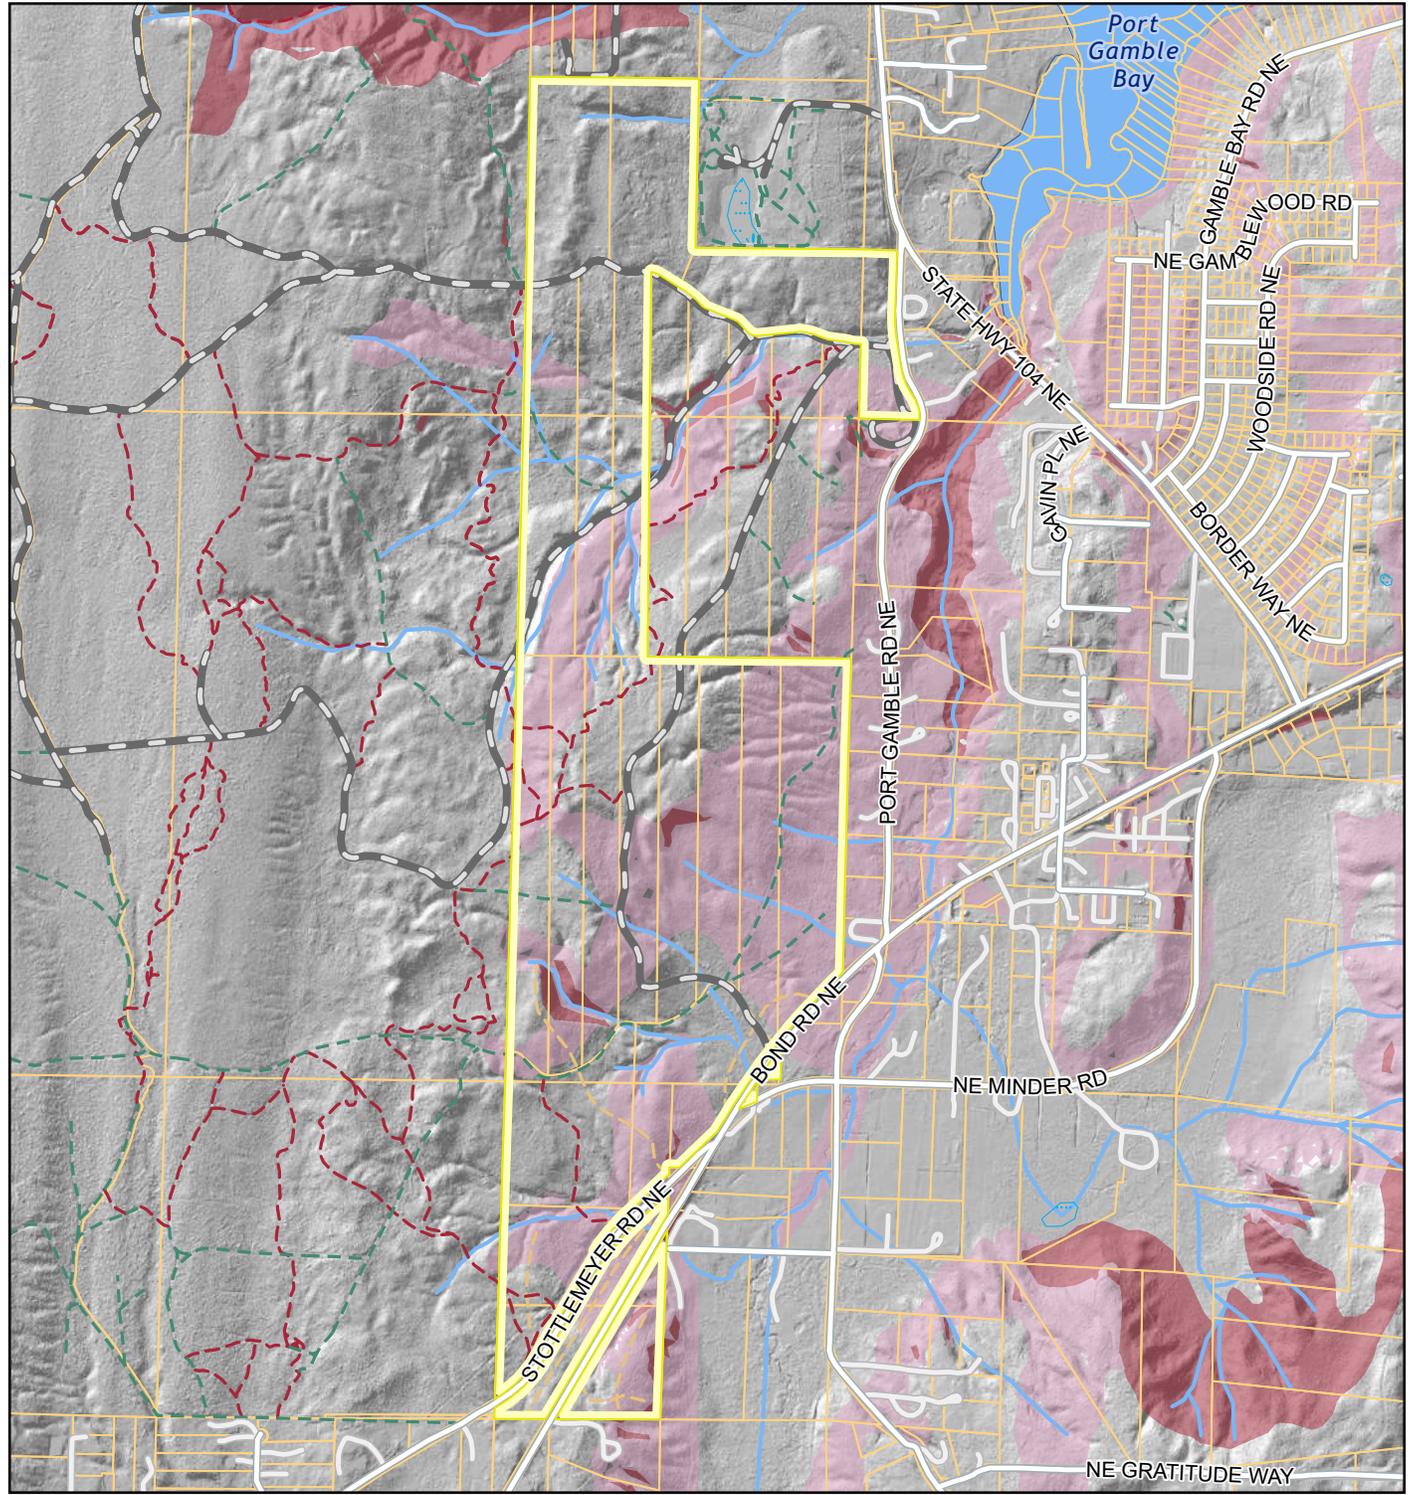
PROJECT NO. 20230264H001	DATE 11/23	FIGURE 6
-----------------------------	---------------	-------------

- SITE
- ROAD
- SERVICE ROAD
- FOOT PATH; TRAIL
- MOUNTAIN BIKE TRAIL
- TRAIL CLEARING 07/23
- PARCEL
- GEOLOGICALLY HAZARDOUS AREAS**
- HIGH HAZARD AREA
- MODERATE HAZARD AREA

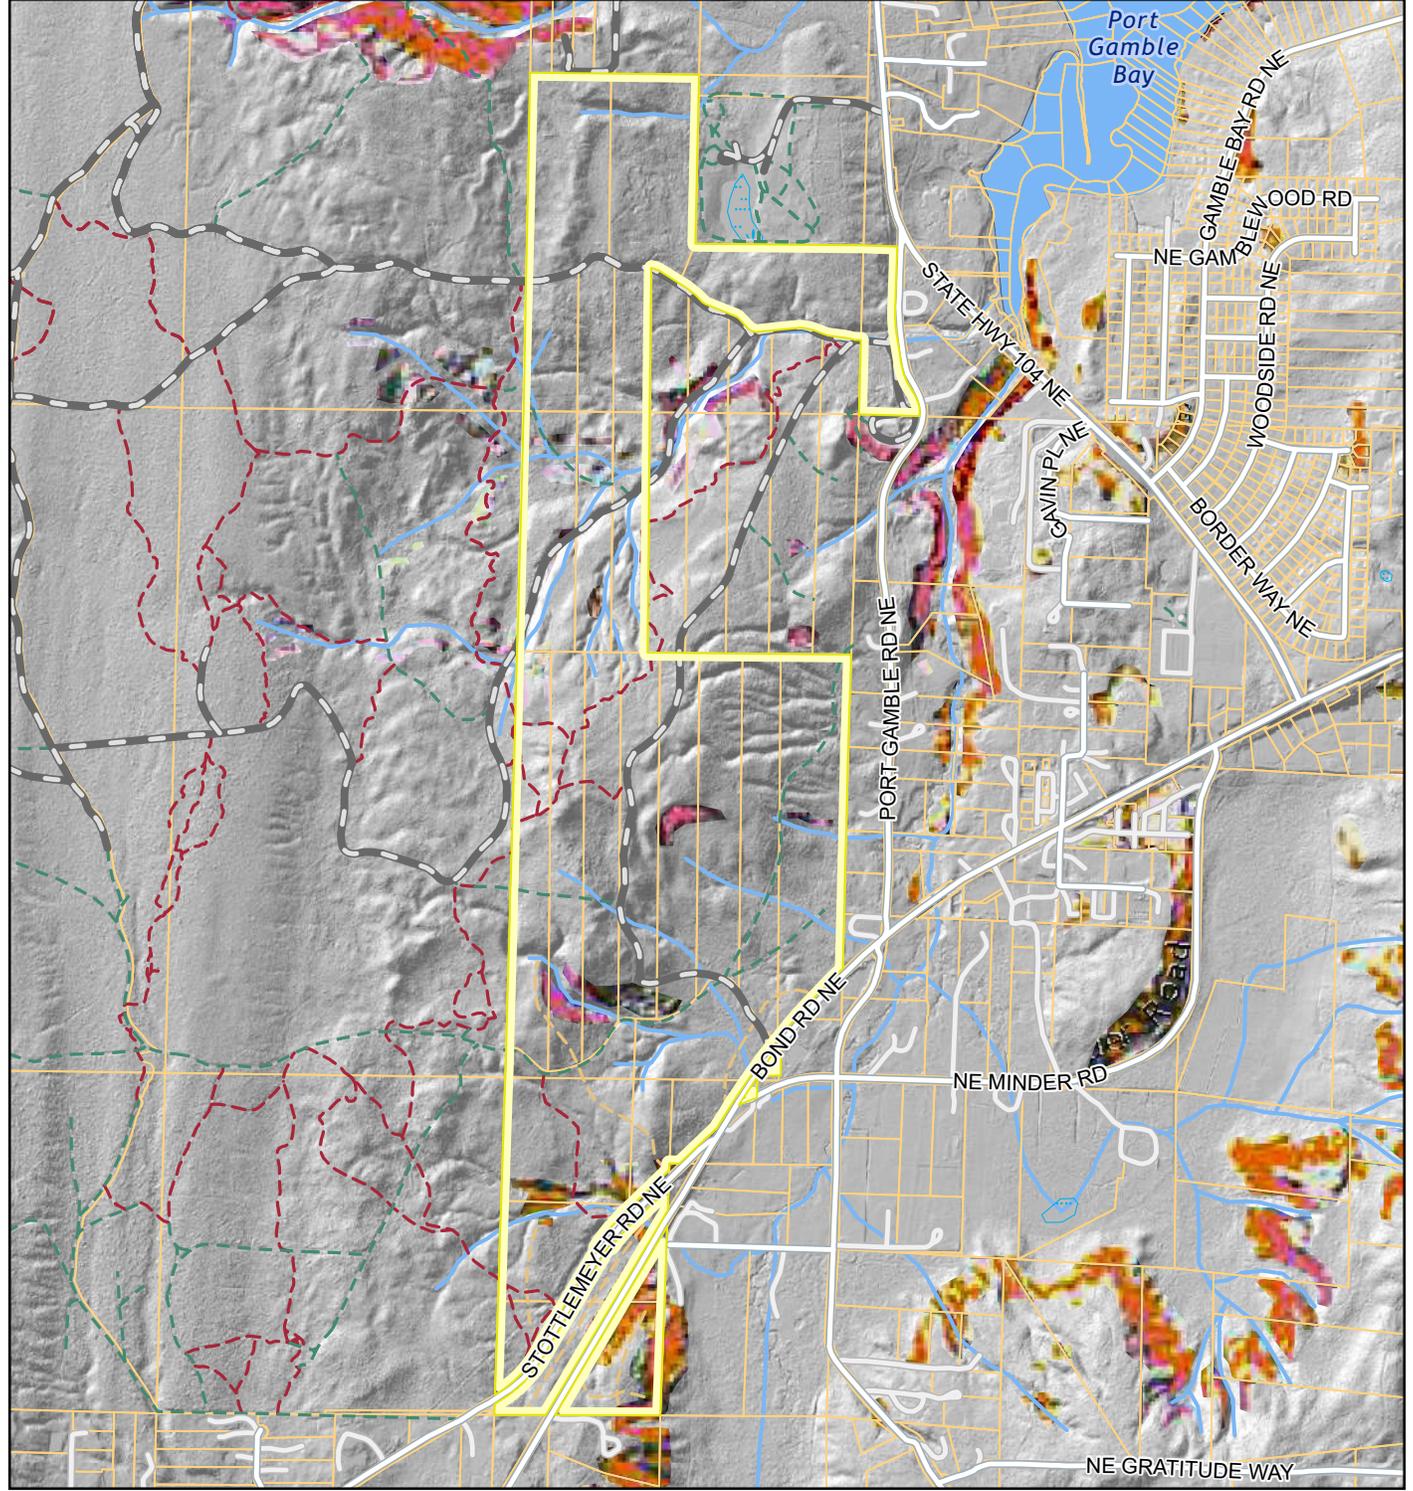
PROJECT NO. 20230264H001	DATE 11/23	FIGURE 7
-----------------------------	---------------	-------------

LEGEND	
	SITE
	ROAD
	SERVICE ROAD
	FOOT PATH; TRAIL
	MOUNTAIN BIKE TRAIL
	TRAIL CLEARING 07/23
	PARCEL
DEEP LANDSLIDE HAZARD	
	HIGH
	MODERATE
SHALLOW LANDSLIDE HAZARD	
	HIGH
	MODERATE

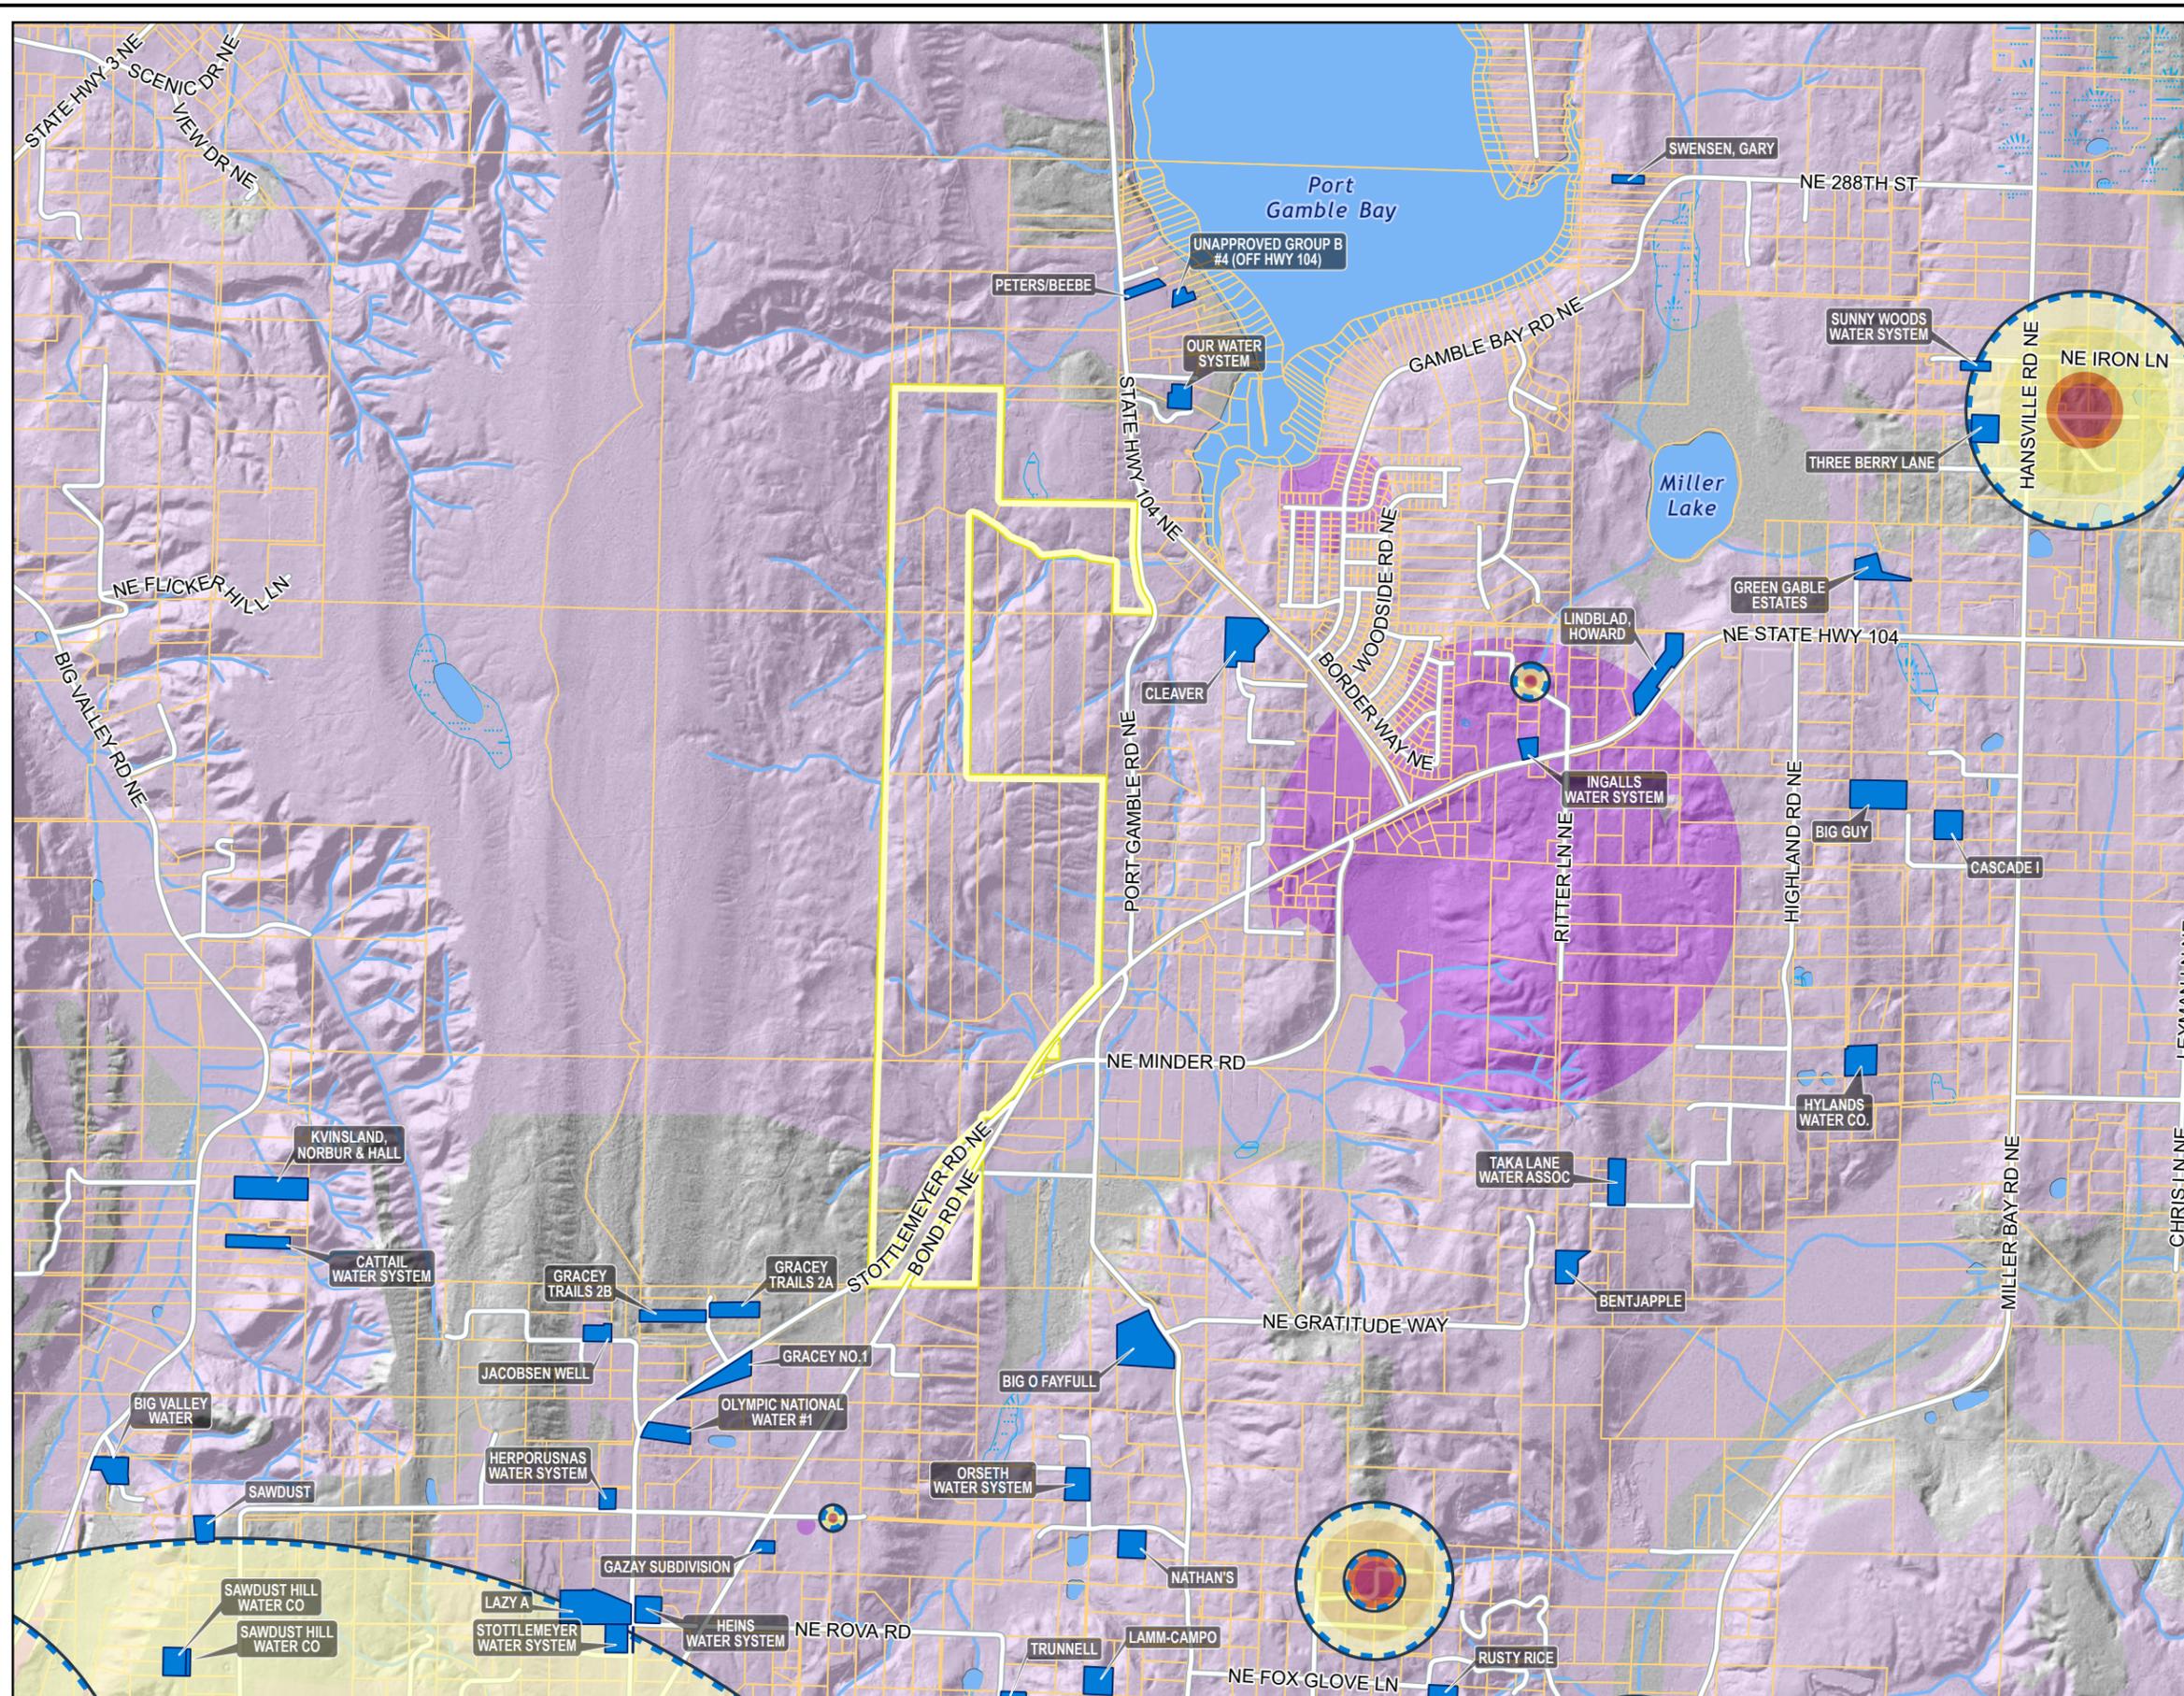
PROJECT NO. 20230264H001	DATE 11/23	FIGURE 8
-----------------------------	---------------	-------------

- LEGEND**
- SITE
  - GROUP B WATER SYSTEMS
  - DOH WELLHEAD PROTECTION AREAS**
  - 10 YEAR TIME OF TRAVEL
  - 5 YEAR TIME OF TRAVEL
  - 1 YEAR TIME OF TRAVEL
  - 6 MONTH TIMT OF TRAVEL
  - CRITICAL AQUIFER RECHARGE AREA**
  - CATEGORY I
  - CATEGORY II
  - PARCEL

Class II CARA that encompasses the entire site (see Figure 8). A number of small water supply systems are present within a ¼ mile of the project to the southwest and east as shown on Figure 8.
