**North Kitsap United Development**  
**FEASIBILITY REPORT**  
KITSAP COUNTY, WASHINGTON

DEA Job No. RAYORYPP0001

Issued: December 8, 2023

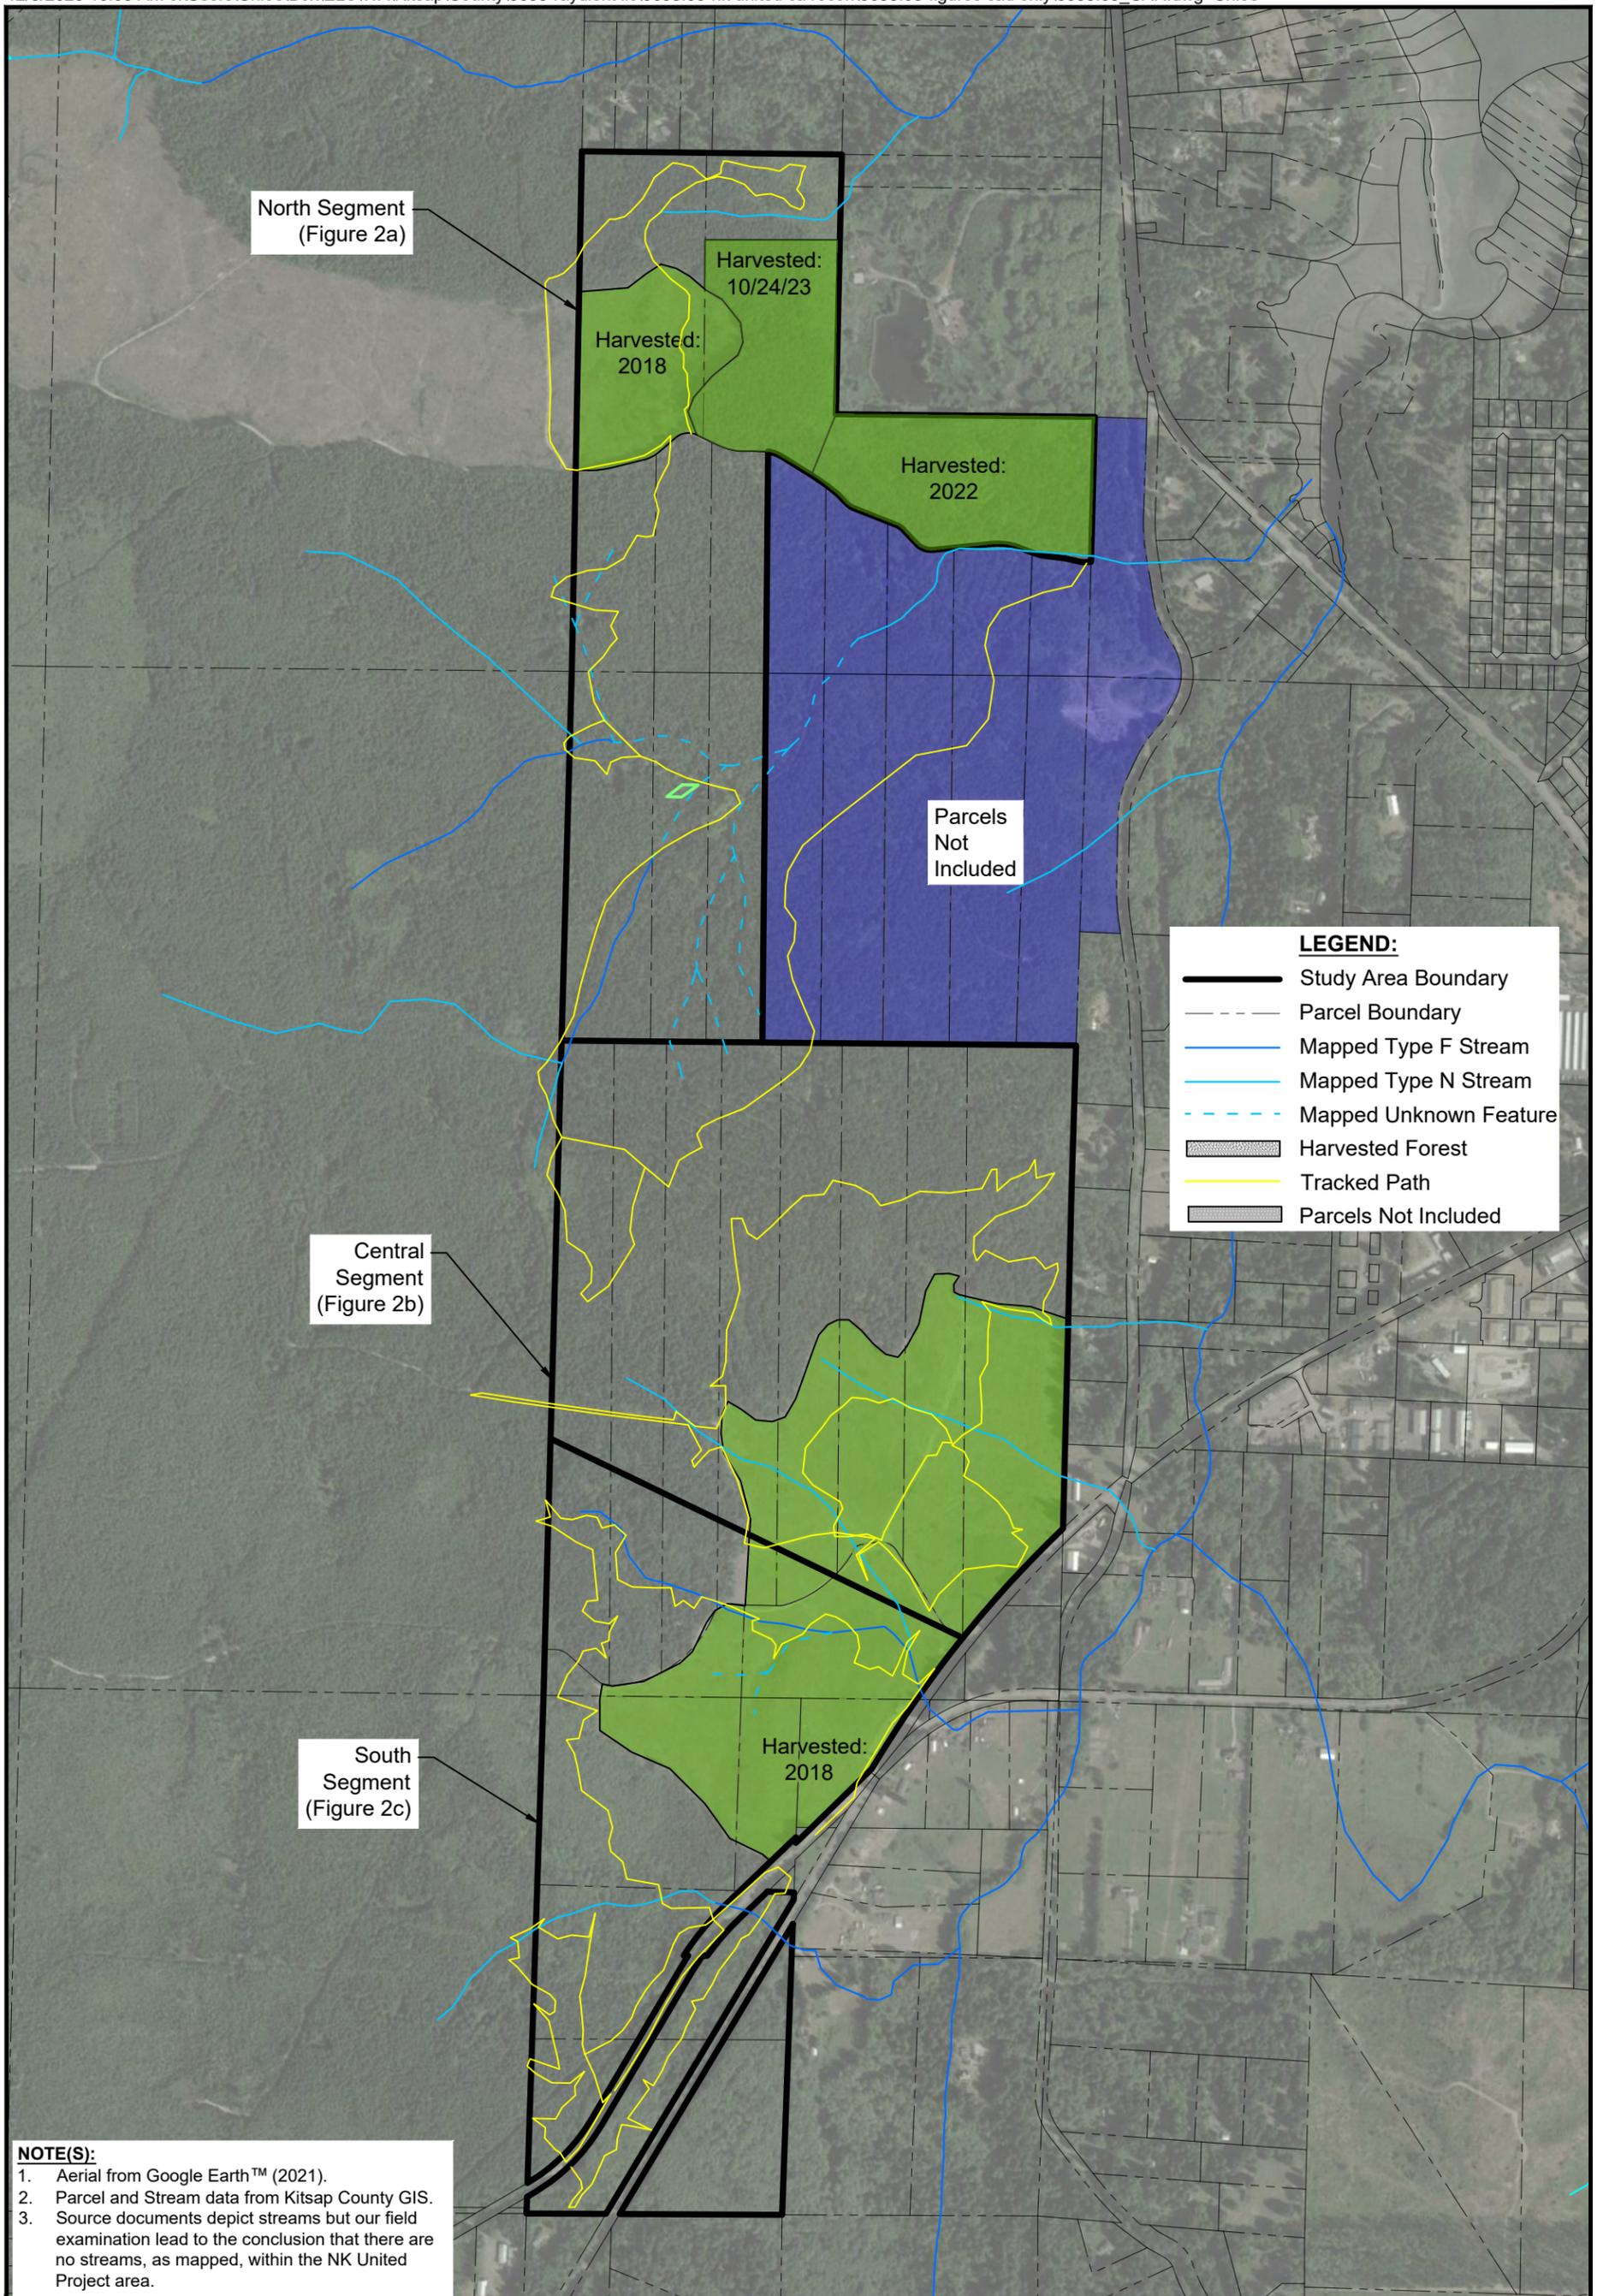
Figure 2  
 EXISTING CONDITIONS - OVERALL  
 Critical Areas Reconnaissance  
 Raydient/NK United  
 Kitsap County, Washington  
 Section 19, 30 & 31, Township 27N, Range 02E, W.M.

- Study Area Boundary
- Parcel Boundary
- Mapped Type F Stream
- Mapped Type N Stream
- Mapped Unknown Feature
- Harvested Forest
- Tracked Path
- Parcels Not Included

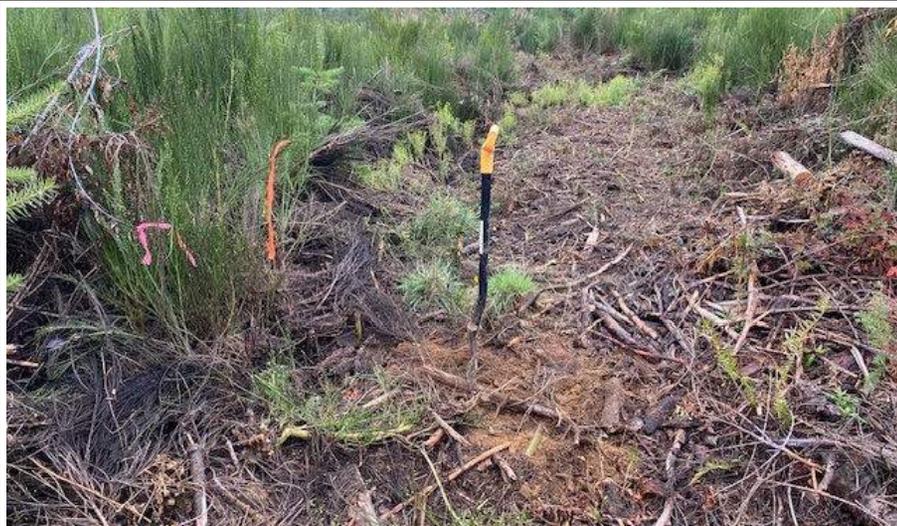
**Photo 1**-Test Plot 3 within the lower end of mapped stream in South Segment. No stream channel this location.

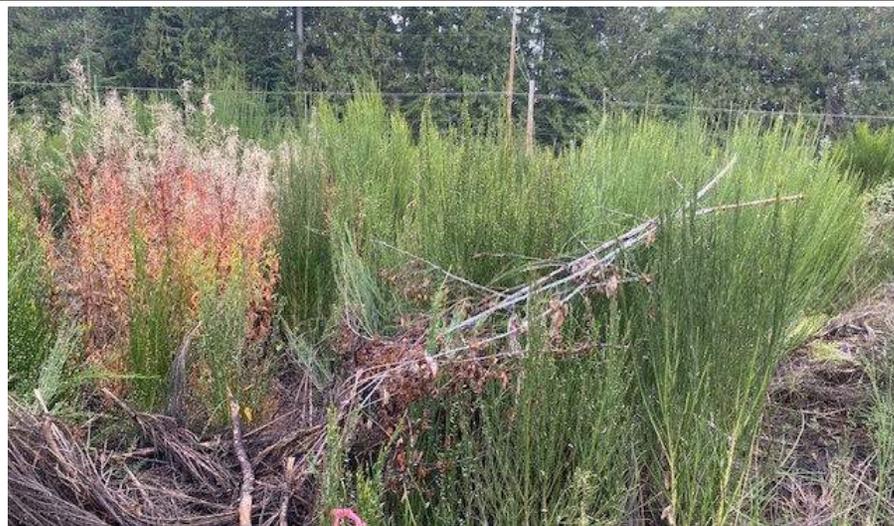
**Photo 2**-Test Plot 3 looking east toward Bond Road/SR 307 along the mapped stream.

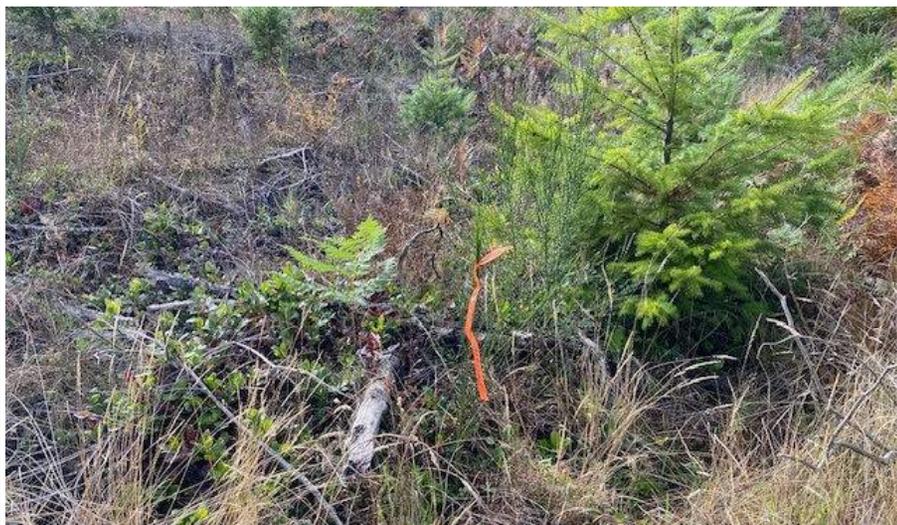
**Photo 3**-Test Plot 8 in the middle segment of the mapped stream within the South Segment. Upland vegetation and no stream channel.

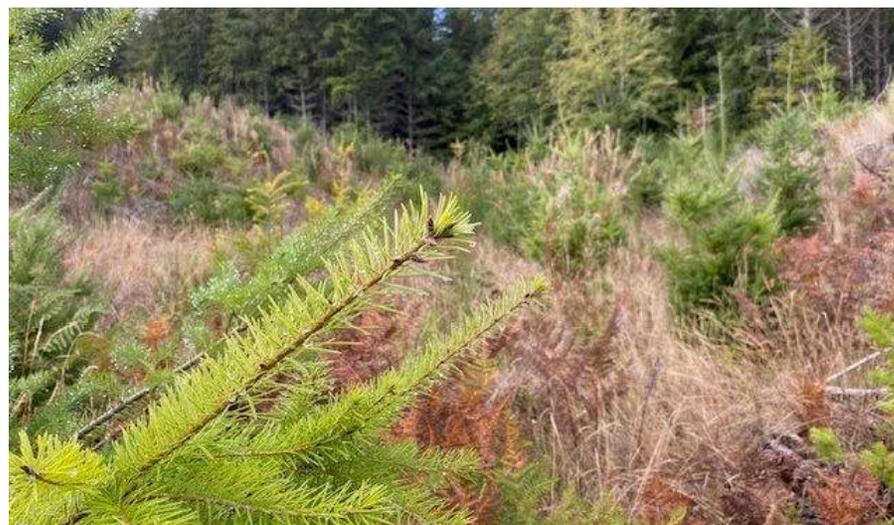
**Photo 4**-Test Plot 8 looking upslope and west along the mapped stream. No stream channel and presence of upland vegetation.

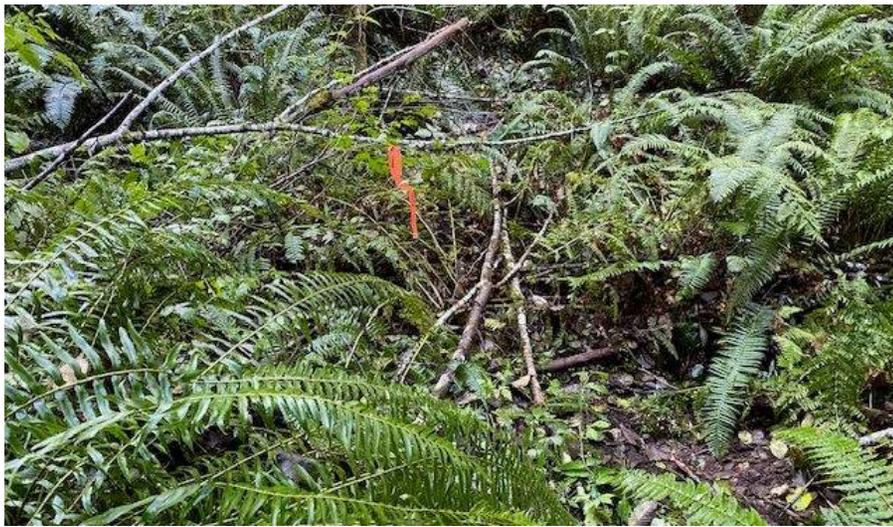
**Photo 5**-Test Plot 11 conducted in southernmost mapped stream in South Segment. No stream observed.

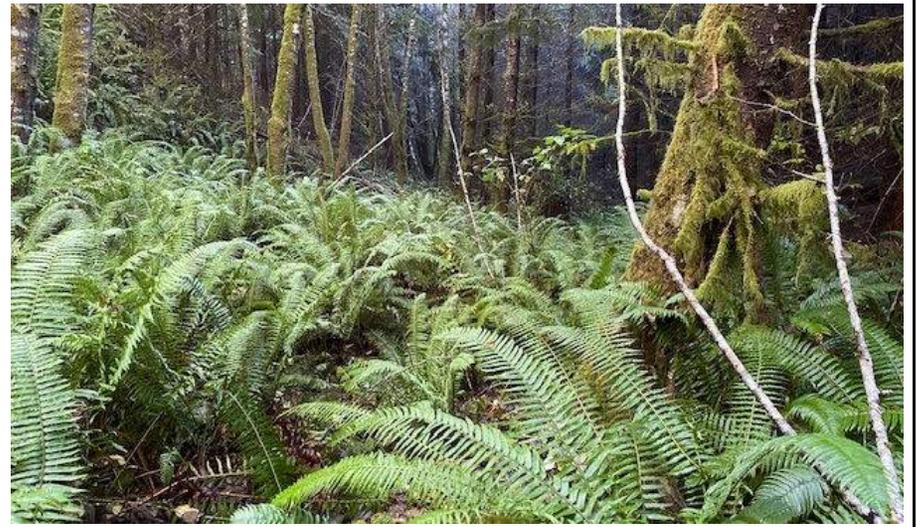
**Photo 6**-Test Plot 11 looking east down the ravine in which the stream is mapped. Dense ferns throughout and no channel observed.

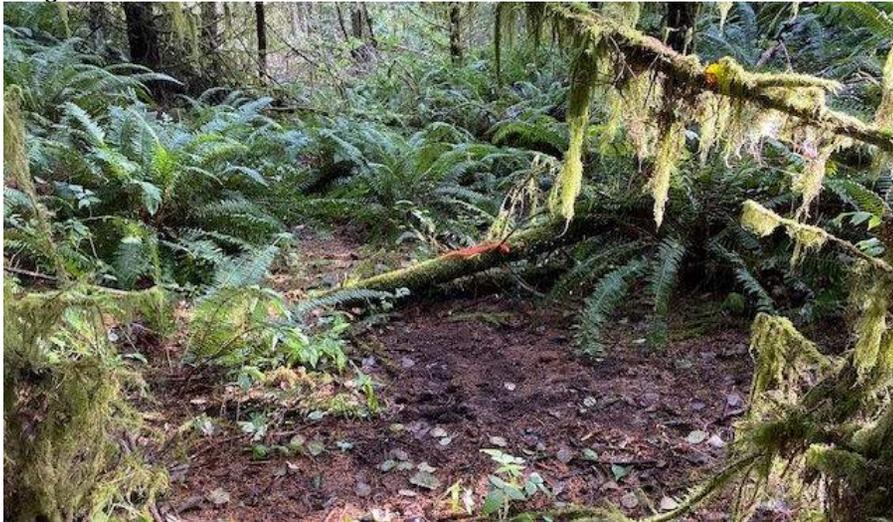
**Photo 7**-Test Plot 18 located at the western extent of the onsite stream in South Segment. Bare ground but no channel observed.

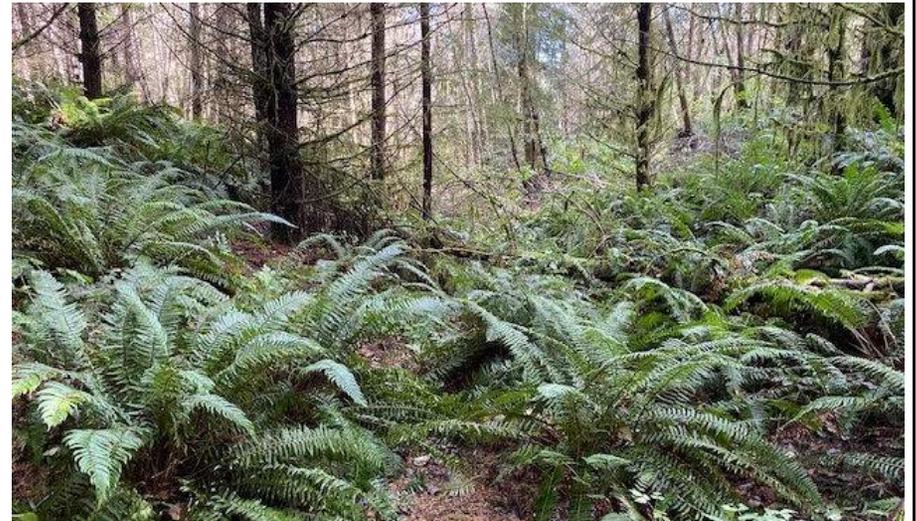
**Photo 8**-Test Plot 18 looking east down the sloping ravine. No stream channel or evidence of water flow.

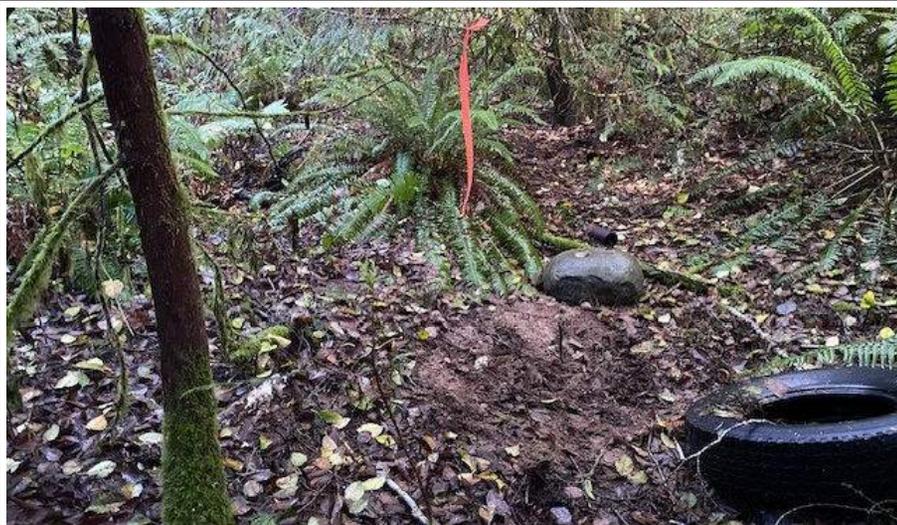
**Photo 9**-Test Plot 20 conducted at the east end of a ravine parallel to Stottlemeyer Road. Not mapped as a stream and none observed.

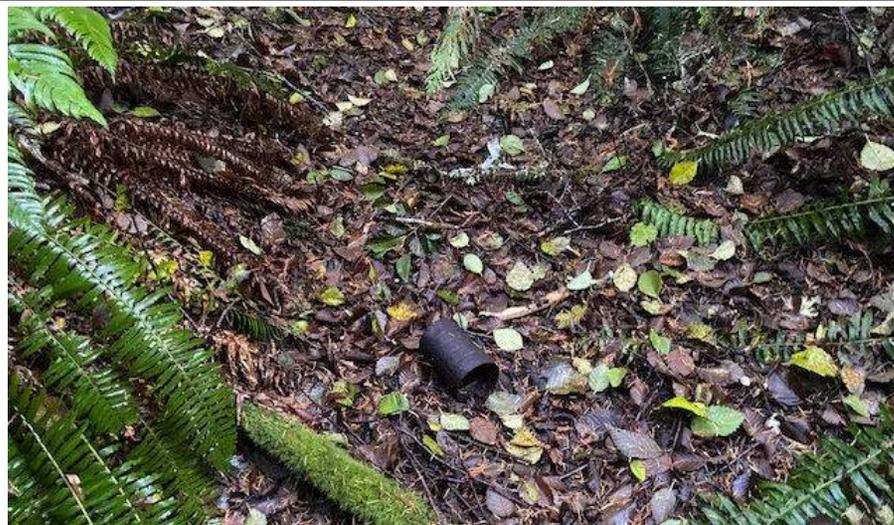
**Photo 10**-Test Plot 20 looking north toward culvert under Stottlemeyer Road. Bare ground with no evidence of water flow.

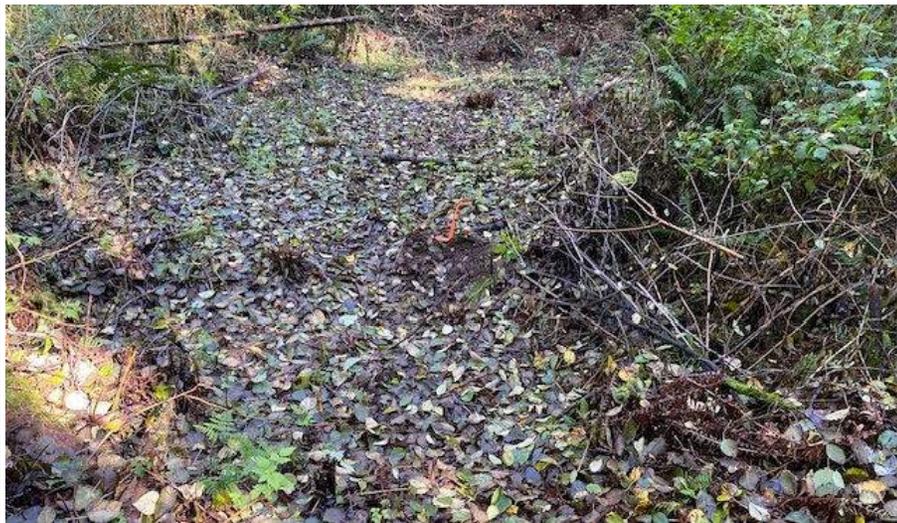
**Photo 11**-Test Plot 21 (east of Stottlemeyer Road) in the southernmost stream in South Segment. Along path cleared for easy access.

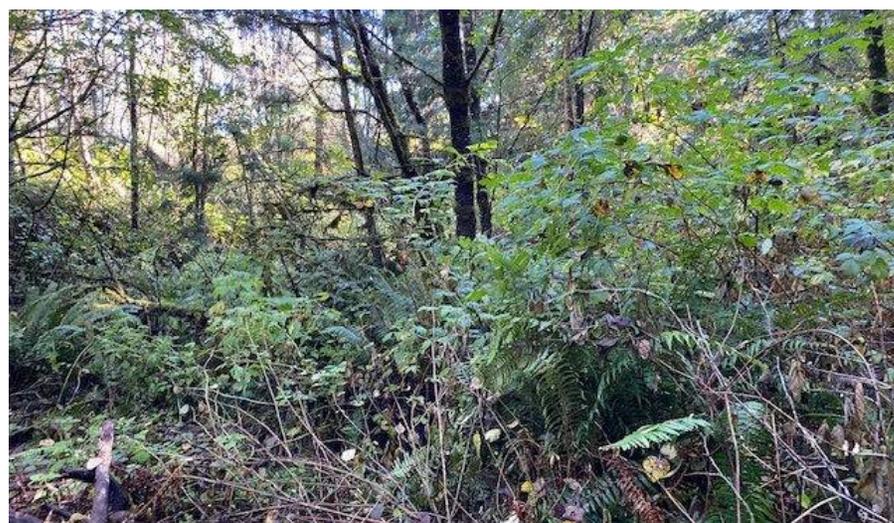
**Photo 12**-Test Plot 21 looking east toward Bond Road (SR 307). Dense vegetation with no channel observed within the mapped area.

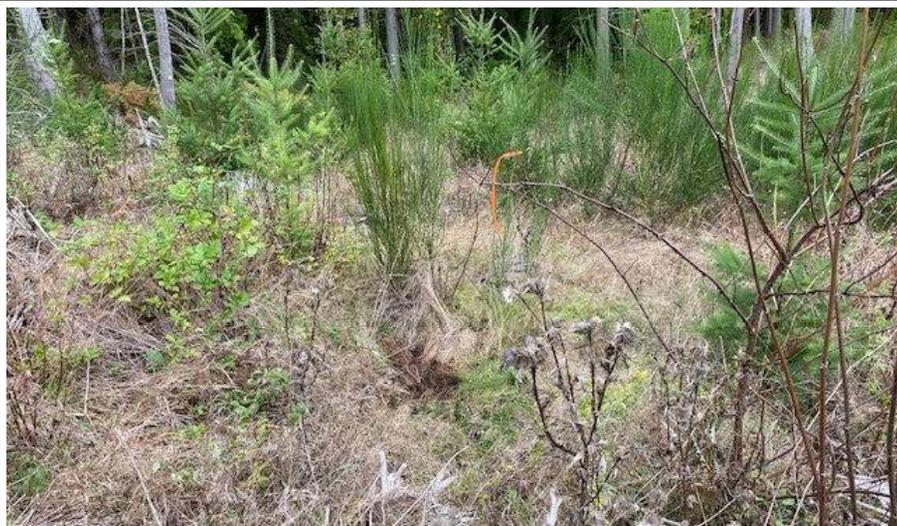
**Photo 13**-Test Plot 35 in the mapped stream at northern edge of harvested forest within the Central Segment.

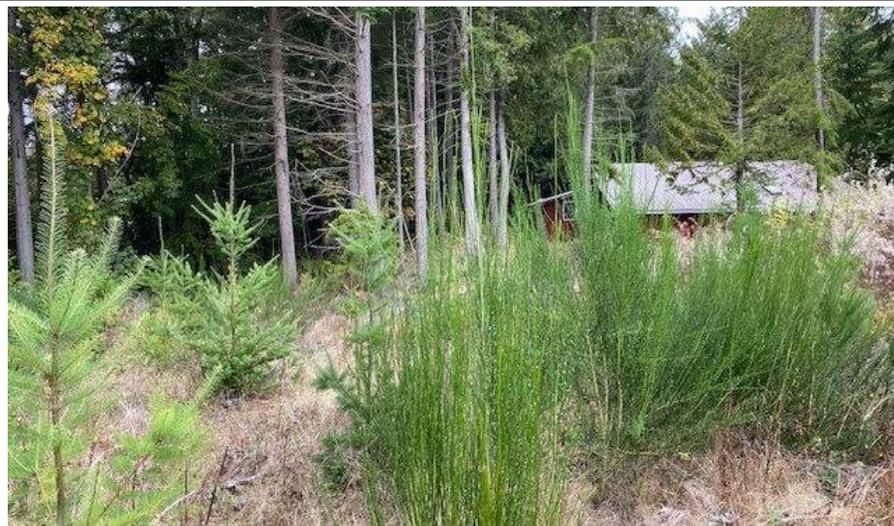
**Photo 14**-Test Plot 35 looking downslope and easterly along mapped stream.

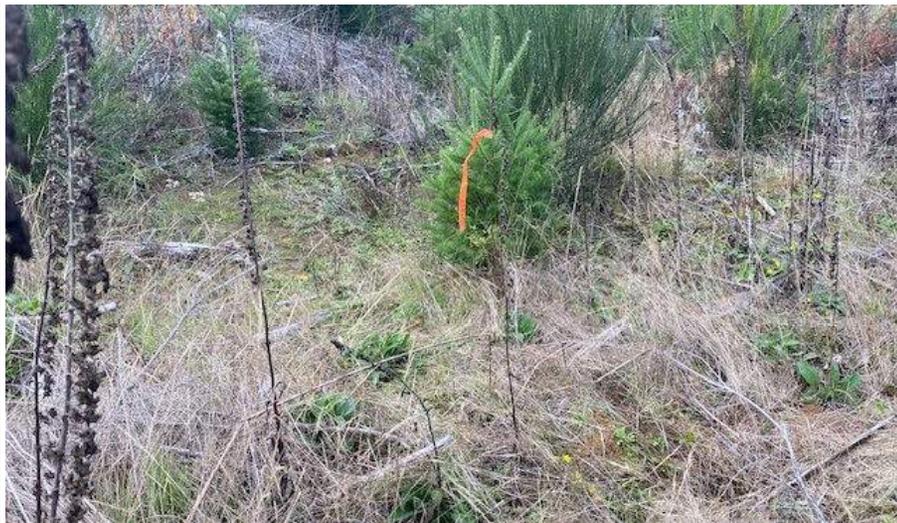
**Photo 15**-Test Plot 38 in topographic trough where stream is mapped. No channel observed and no evidence of water flow.

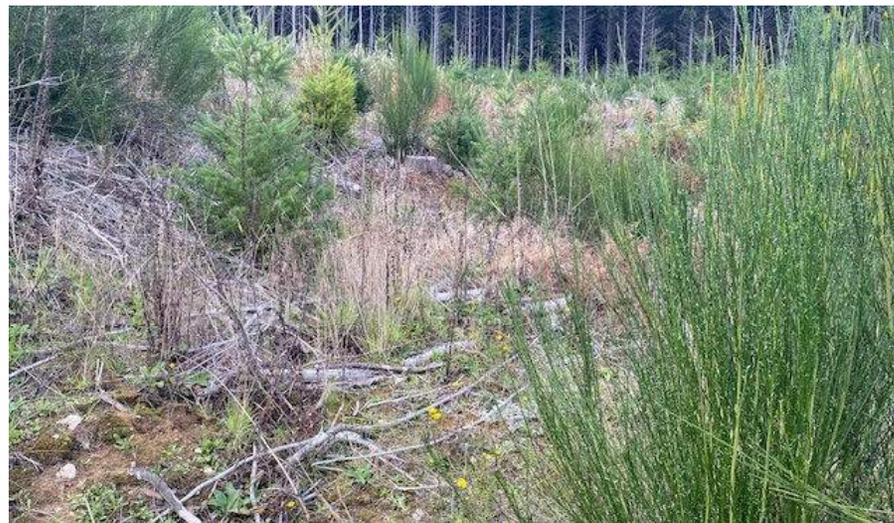
**Photo 16**-Test Plot 38 looking southeasterly down the topographic trough. No stream channel or evidence of water flow.

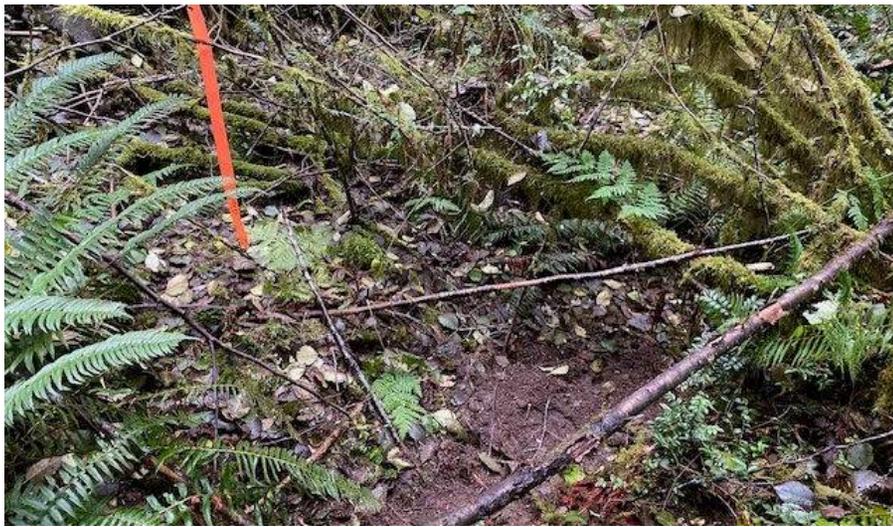
**Photo 17**-Test Plot 30 located within a ravine where a stream has not been mapped. No stream or evidence of water flow observed.

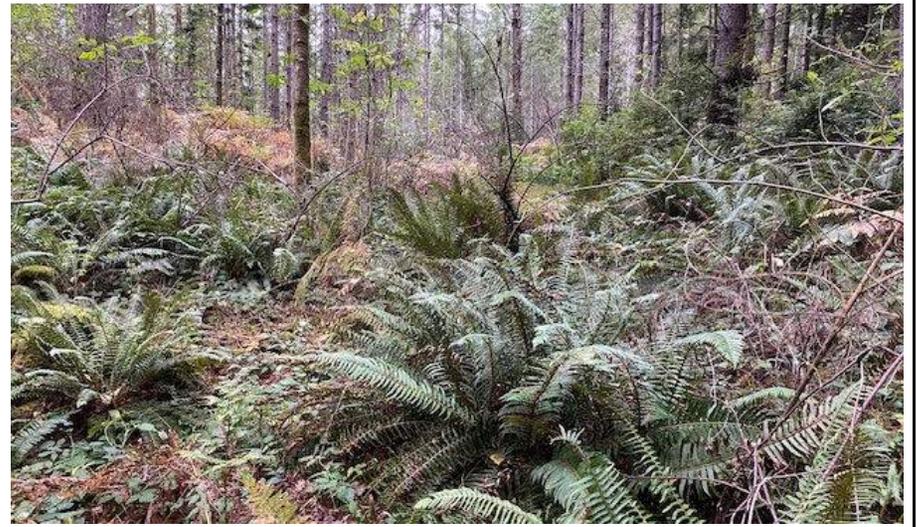
**Photo 18**-Test Plot 30 looking downslope and easterly within the topographic trough.

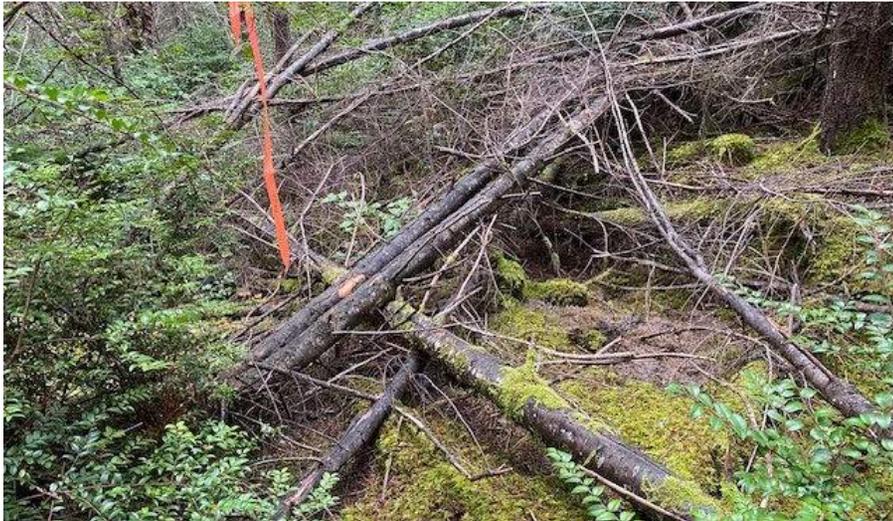
**Photo 19**-Test Plot 44 in topographic trough with no mapped stream. Downslope of a large slash pile within the trough.

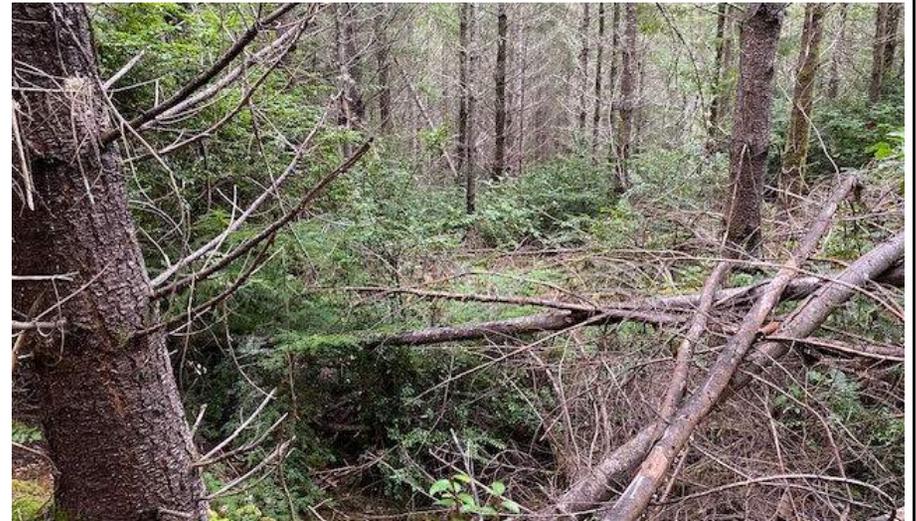
**Photo 20**-Test Plot 44 looking downslope and north into trough. No stream or water flow indicators present.

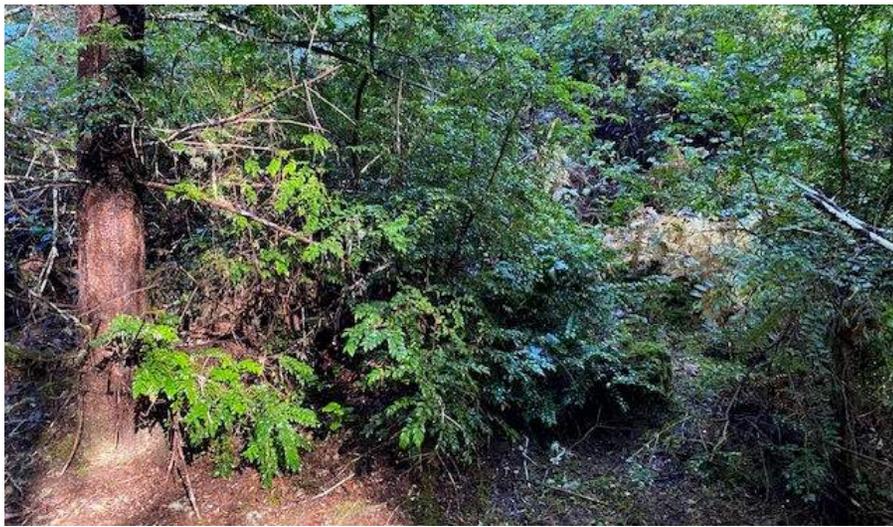
**Photo 21**-Photo Point 5 looking east to document site conditions. A stream was not observed within this area.

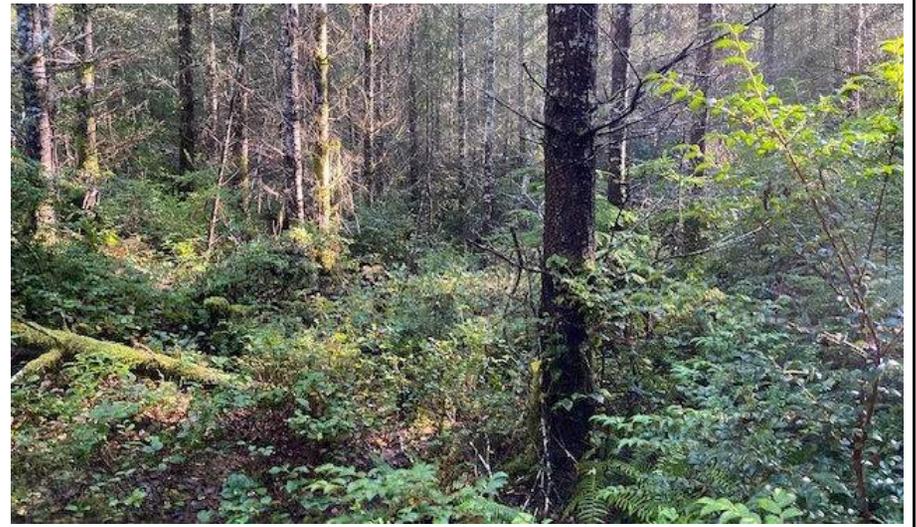
**Photo 22** Photo Point 5 south looking downslope where there is dense vegetation cover not indicative of stream conditions.

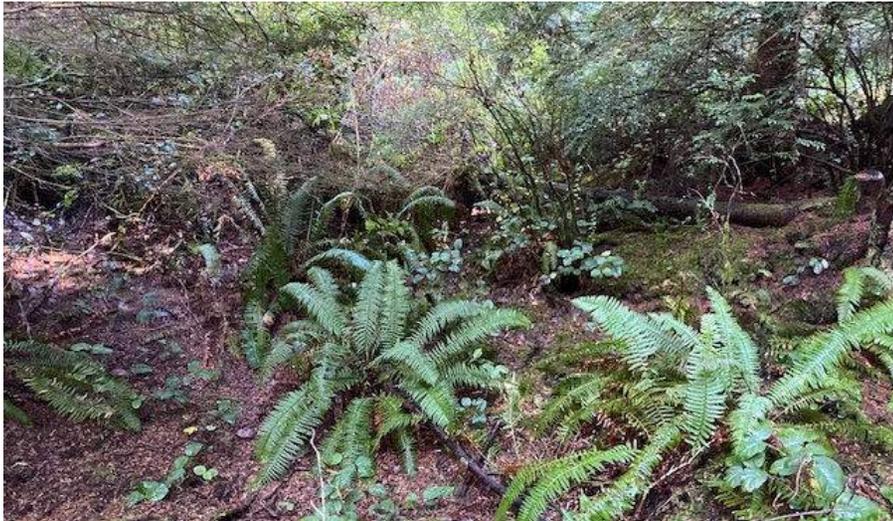
**Photo 23**-Photo Point 10 is located along a topographic trough that lies west of Stottlemeyer Road. Non mapped stream/no stream.

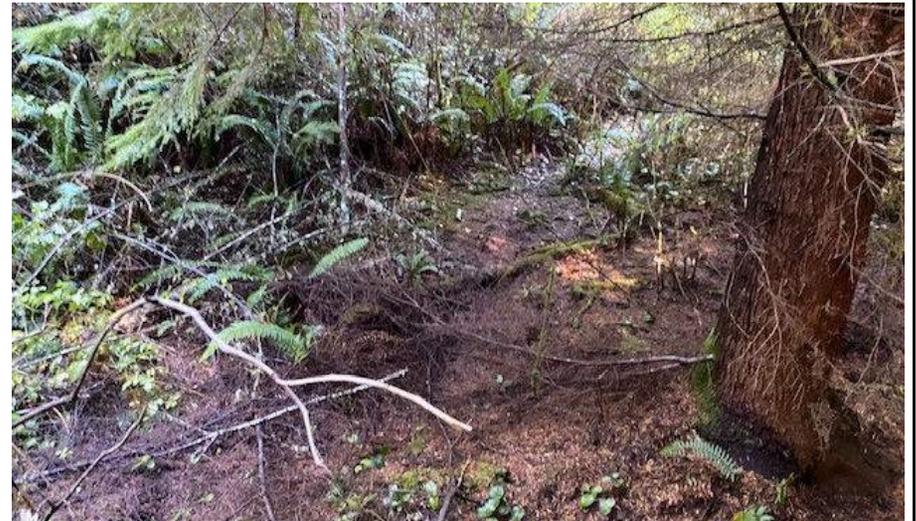
**Photo 24**-Photo Point 10 west shows another area of the topographic trough where no stream was observed during the 10/23 site visits.

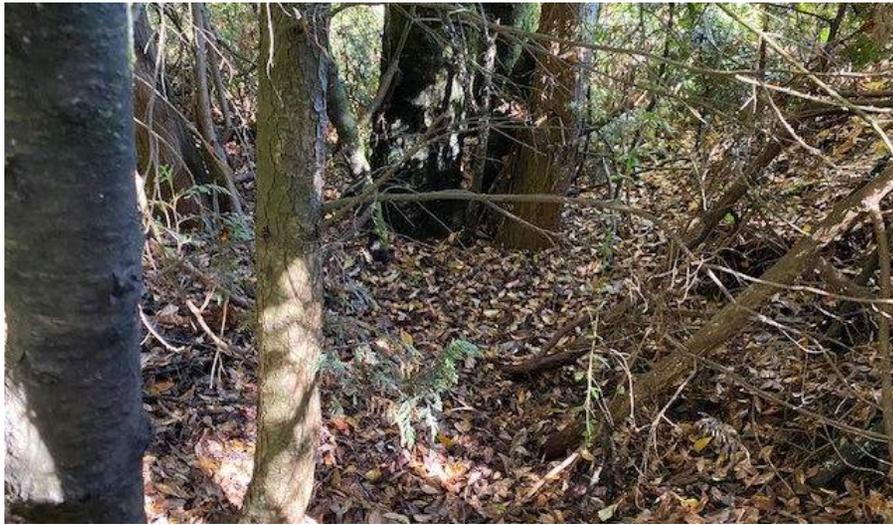
**Photo 25**-Photo Point 13 looking north along a topographic trough at the northern tip of South Segment between Stottlemeyer and Bond Roads.

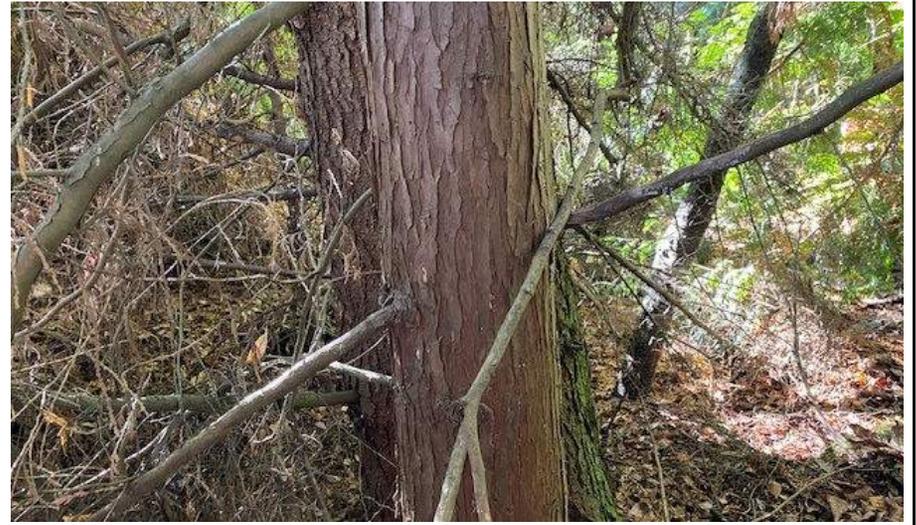
**Photo 26** Photo Point 13 looking south along the low area along Bond Road.

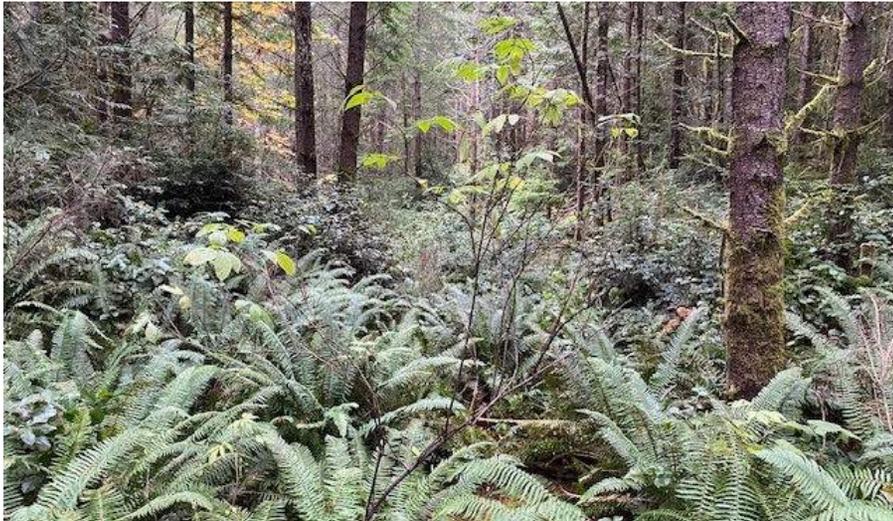
**Photo 27**-Photo Point 18 looks easterly down a topographic trough where no stream was mapped in the Central Segment.

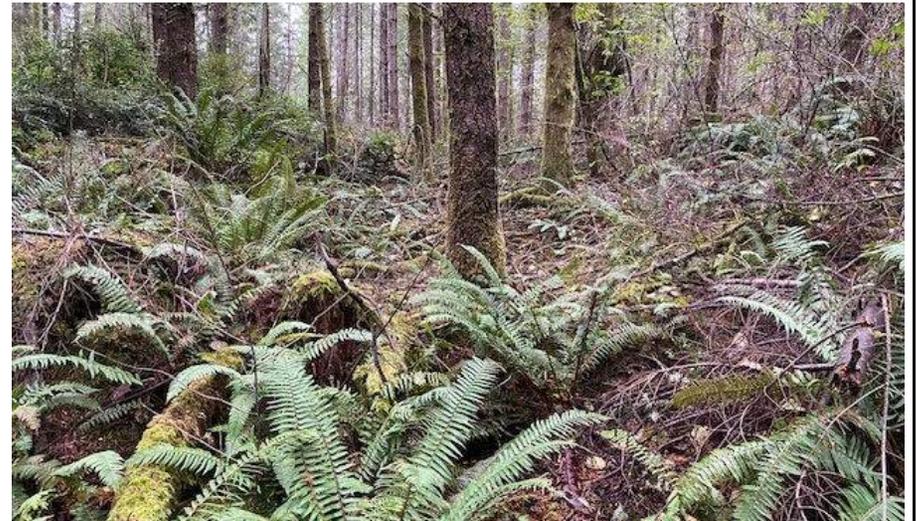
**Photo 28**-Photo Point 18 looks westerly up the topographic trough across the north end of the Central Segment. No stream observed.
